Engineering Assessment of Big House at Summit Station, Greenland

Final Report

Lynette A. Barna, Keran J. Claffey, James S. Buska,
and Jennifer L. Mercer

April 2011

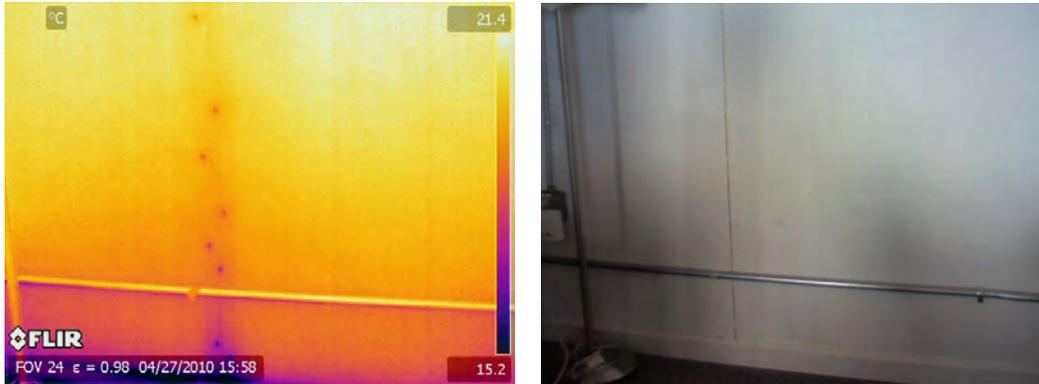
Significant impacts from the periodic lifting of the building were not observed in the IR imagery. As an example, separation between seams in abutting structural insulated panels (SIP) in the walls was minor. A typical

seam is shown in Figure S-2. The IR and visual images are of the north interior wall in the dining area.

Figure S-2. Vertical seam between SIPs does not show separation (north interior wall in dining area).

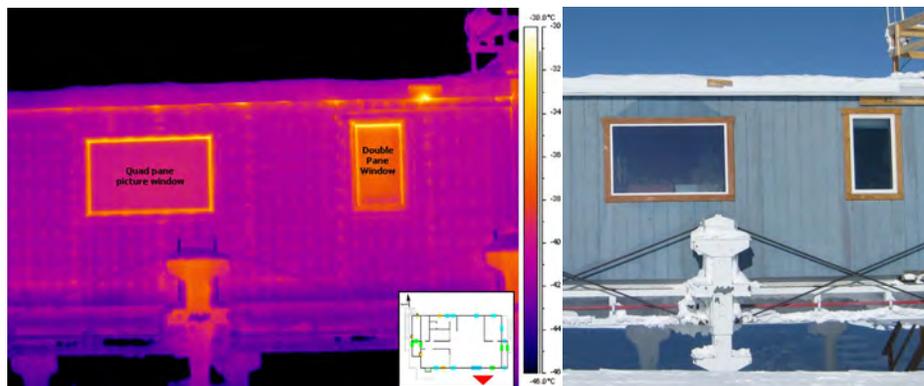
The exterior IR imagery of the double-paned windows showed more heat loss than found for the quad-pane window. This is seen in the IR imagery in Figure S-3, showing the southern exterior side of the building. A well sealed opening during the installation of higher quality windows maximizes the anticipated energy savings. In addition, installing and sealing the window opening are important so as not to compromise the energy savings from the higher quality window.

Figure S-3. Quad-pane window reduces heat loss compared to a double-pane window (exterior south side).

- Replace the remaining double-paned windows with triple-paned windows. This will improve the energy efficiency. This task has been identified and planned by CPS for improvement.

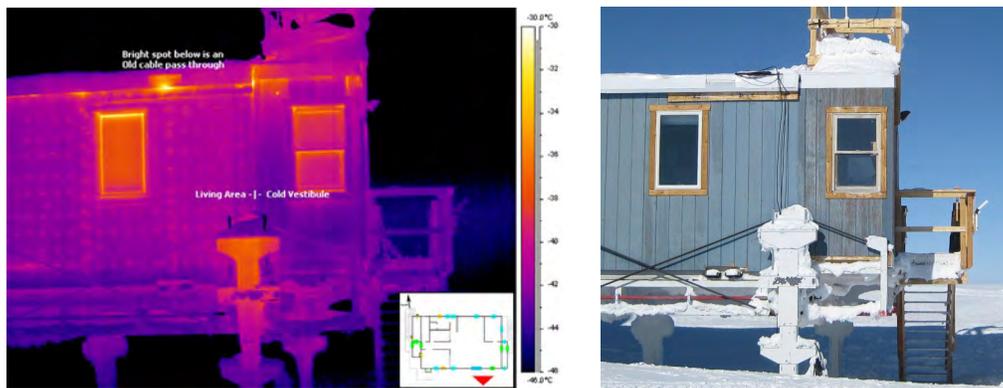
The access hatch to the roof penetrating the ceiling in the unheated east vestibule is a source for heat loss and creates a buildup of frost along the interior of the opening. Heat sources are the shared wall with the main room, and the sunlight that comes through the southern window.

Similarly, more heat loss was observed along the south side fascia, particularly toward the eastern end of the building, where instruments had previously been installed and in locations where repairs had been made to the metal flashing. Figure S-4 illustrates the heat loss observed in the IR imagery from the south side eastern end of the building. The cable pass-through to the radome (Fig. S-5) is an example where the cable pass-through is well insulated and little heat loss occurs.

Figure S-4. Difference in thermal envelopes between heated main room and unheated east vestibule, and heat loss along fascia (exterior south side).

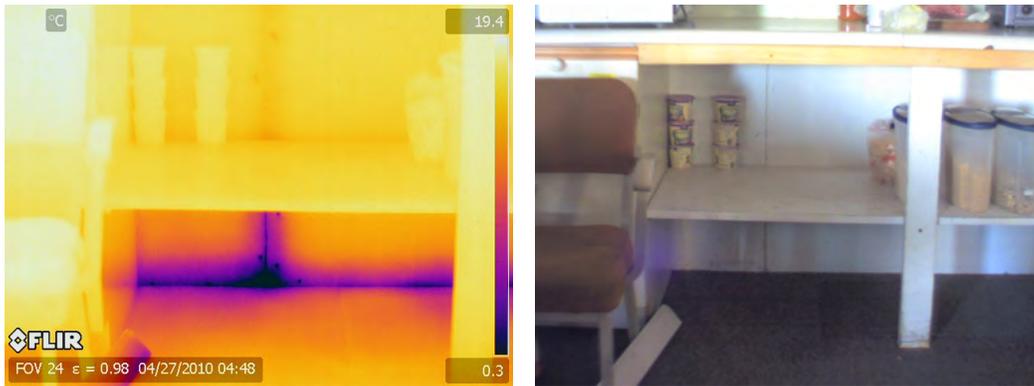
On the main floor, where the wall is joined to the deck, several areas were identified. Locations that appeared to have more heat loss included a cold spot under the counters in the main room, as shown in Figure S-6 (which was immediately caulked), an area in the northeastern corner of the office (which may not be noticeable owing to storage under the desk), and a location in the bathroom along the baseboard where frost had developed.

Figure S-6. Cold spot under the counter in the south wall of the main room.

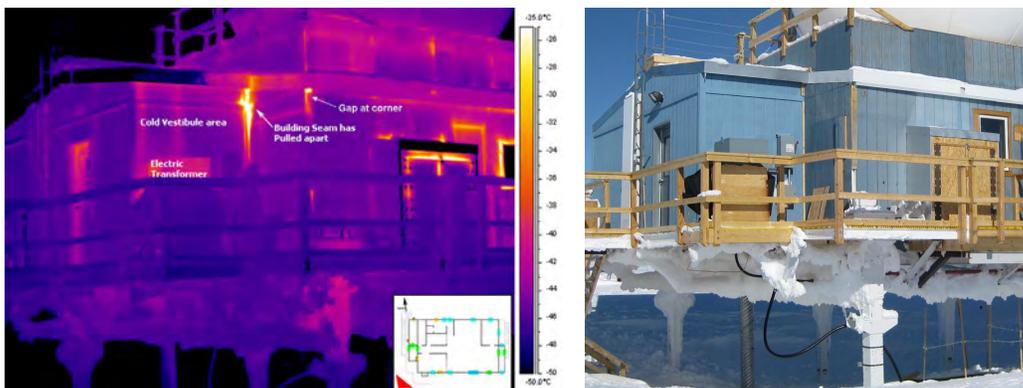
Very high heat loss was observed at the southwestern corner of the structure where the west vestibule connects to the main building (Fig. S-7). This location was identified and noted for repair when the penetration survey was conducted by CPS.

Figure S-7. Excessive heat loss at a gap located in the southwestern corner.

- Repair the two gaps on the southwestern side of the building, at the interface where the west vestibule connects to the main building and the gap at the southwestern corner.

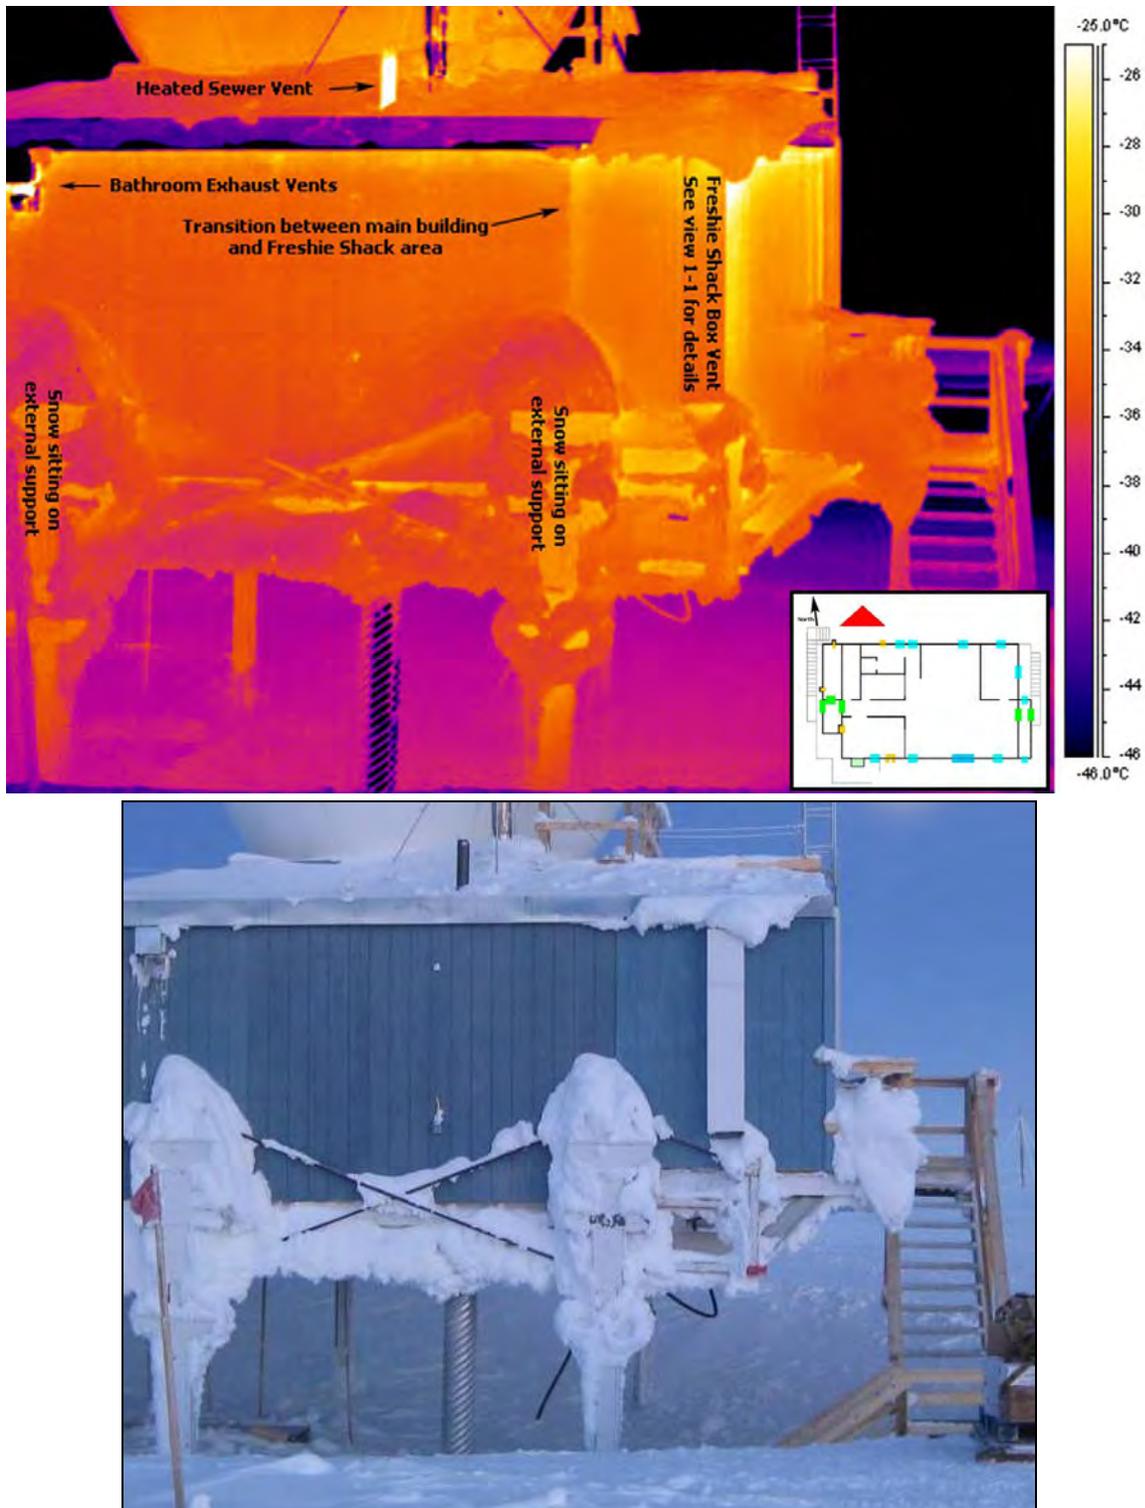
Beginning on the north side western end of the Big House, **View 1** (Fig. 14) includes the exterior wall of the mechanical room, freshie shack, and access stairway of the west entrance. The west vestibule (with dimensions of 2 m wide \times 6.8 m long) was added to the main structure in 2006 (CPS and NSF 2009). There is a slight amount of frost buildup at the bottom of the fresh air vent to the freshie shack. The bright spot on the roof is the heated vent pipe for the sewer in the mechanical room. The transition between the original construction and the freshie shack shows some heat loss at the common wall between them. The bright area along both the sides and bottom of the fresh air vent indicates heat loss out of the freshie shack, although the vent on the inside was covered with cardboard. The freshie shack consists of a 100-mm SIP, covered with an interior metal skin commonly used for food storage. The exterior of the west vestibule is 12.5-mm T-111 siding and, on the north side of the building, is aligned flush with the existing T-111 siding.

Figure 14. View 1 showing location (inset), thermal, and visual image of the exterior North side West end.

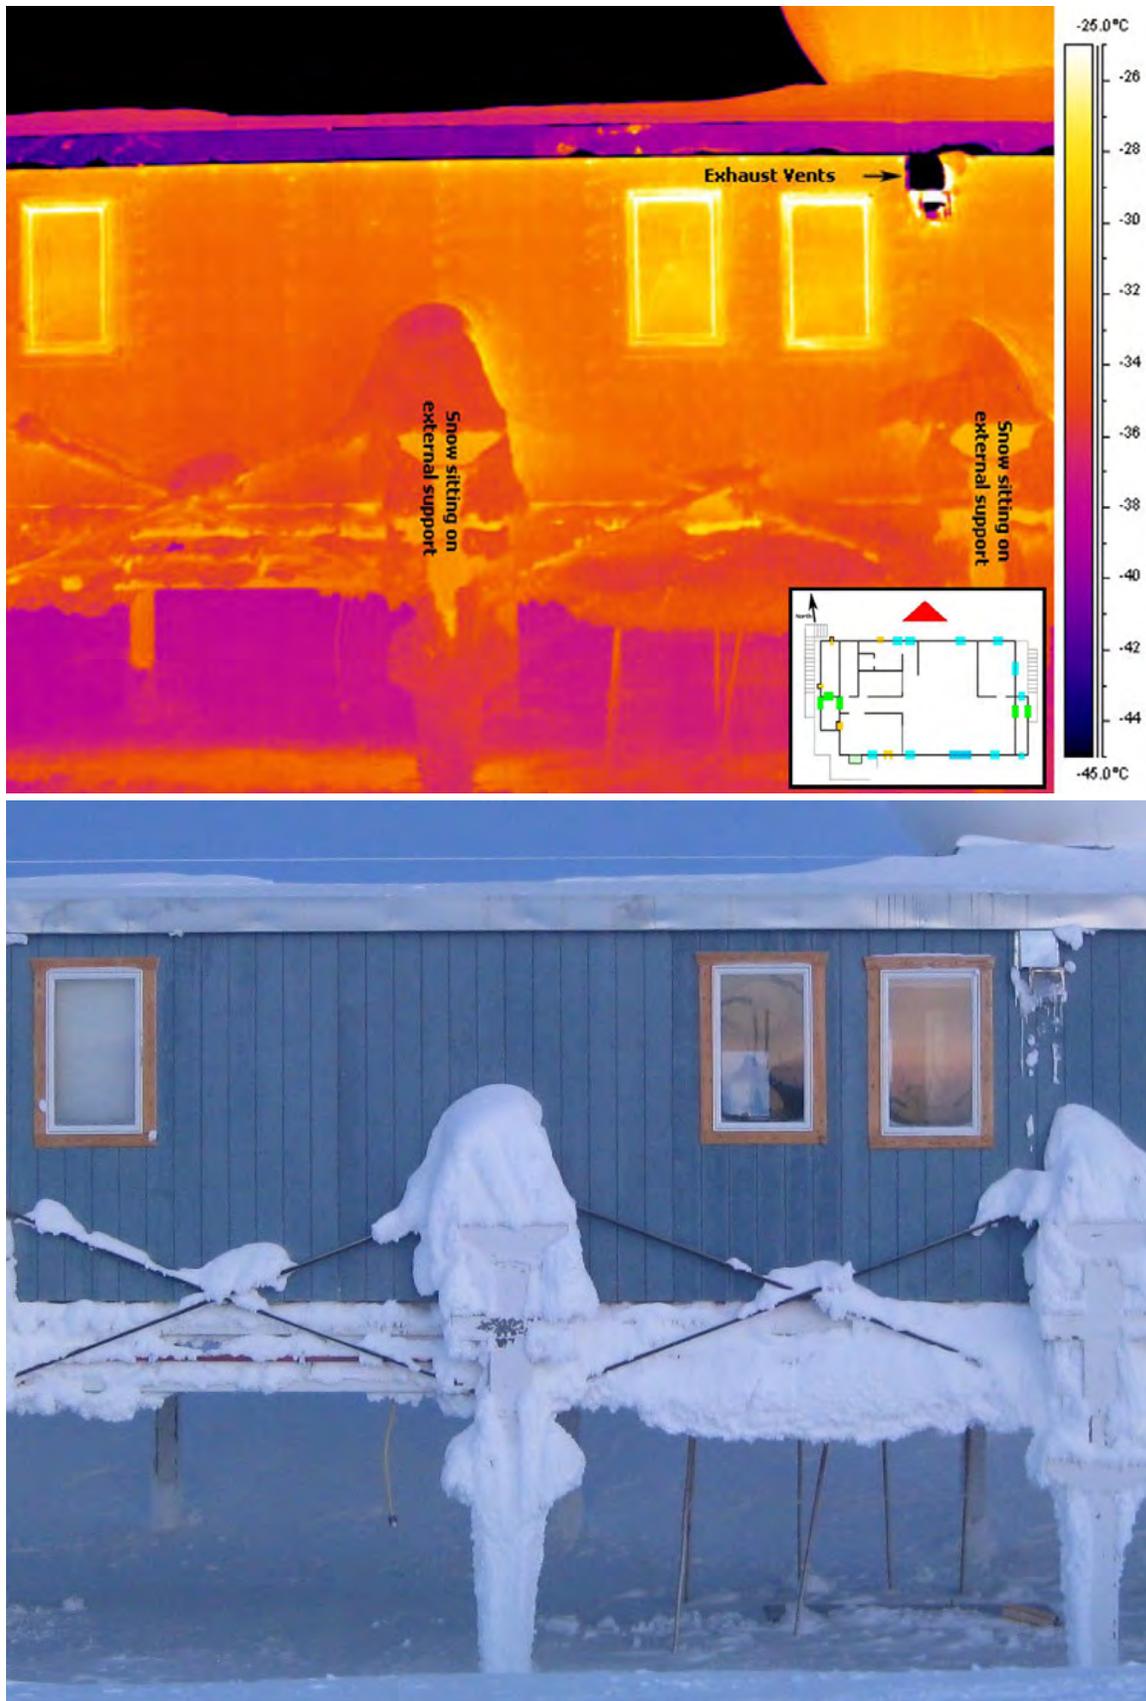
The set of images in Figure 15 are from **View 2** in the mid-section of the north exterior wall. The main room window is on the far left and the windows to the right are those in the hallway and laundry room/bathroom.

Figure 15. View 2 showing location (inset), thermal, and visual image of the mid-North exterior wall in the vicinity of the laundry room and main room.

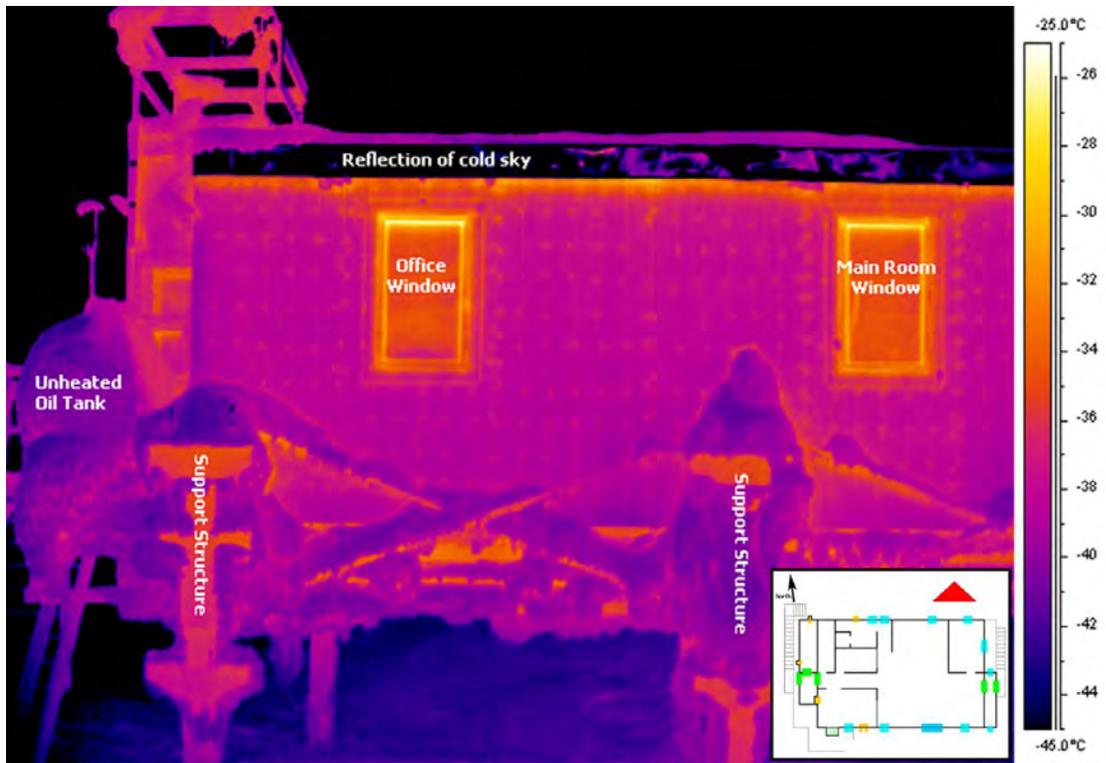
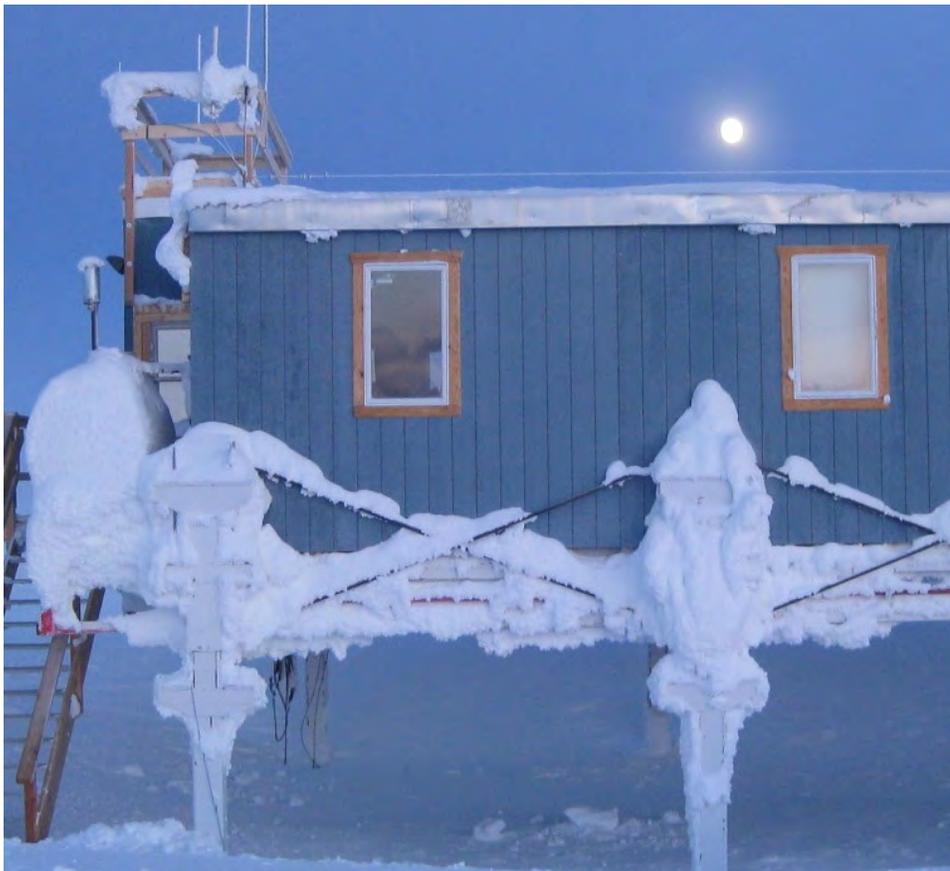
The images at the eastern end of the north wall, as shown in **View 3** (Fig. 16), include the office window (left) and the main room window (right). Both windows are wood frame, double-pane casement. The fuel tank on the deck is the round, snow-covered object located on the far left in the image. Consistent with the windows in **View 2**, the headers at the top of both windows have a brighter area in the IR image, indicating heat loss, and there is more heat loss through the window pane compared to the wall. Heat loss at the top of a window is common as this is a discontinuity within the wall system, and there may be a gap between the wall and the window frame.

Figure 16. View 3 showing location (inset), thermal, and visual image of the eastern end of the North exterior wall in the vicinity of the office and main room.

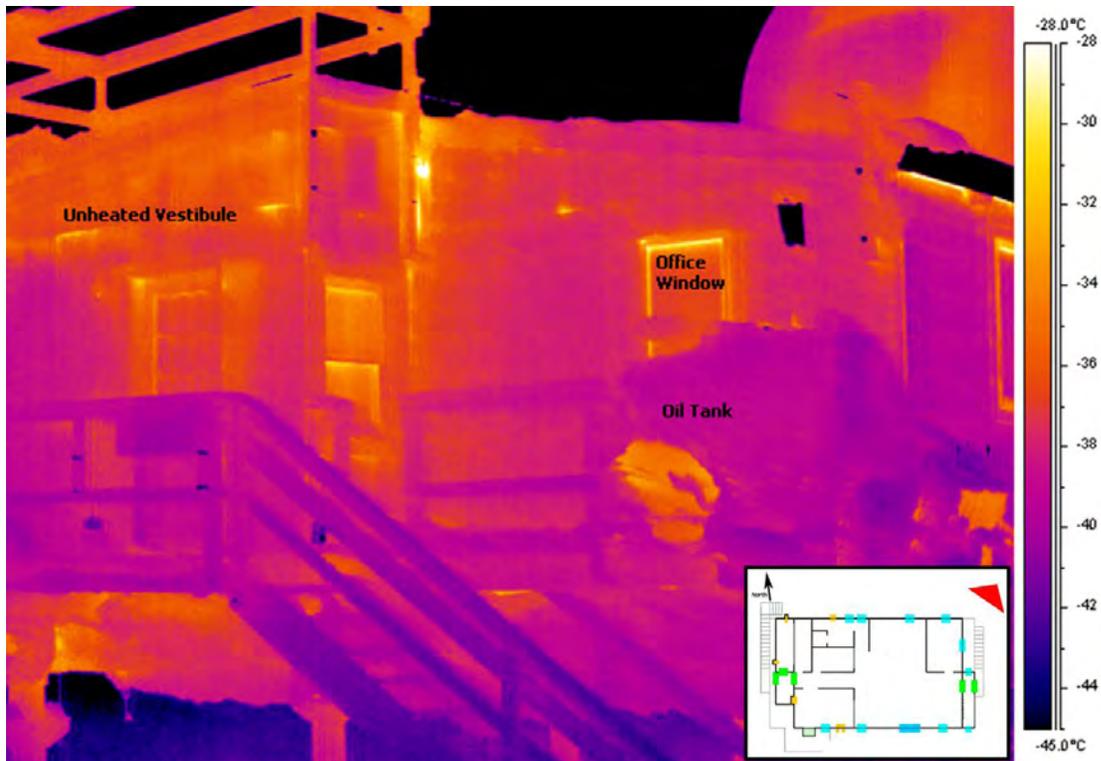
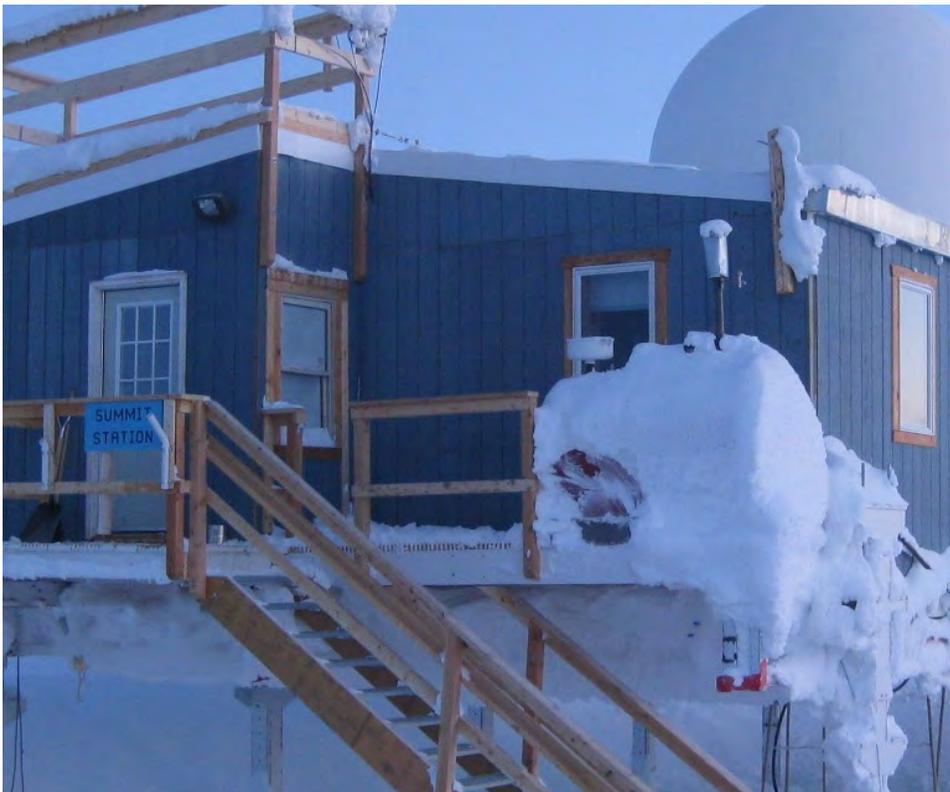
horizontal line above the doorway in the vestibule shows heat loss through the seam where the ends of the T-111 sheathing butt together. This is also clearly visible in the next IR image.

Figure 17. View 4 showing location (inset), thermal, and visual image of the northeastern corner including the office and eastern unheated vestibule.

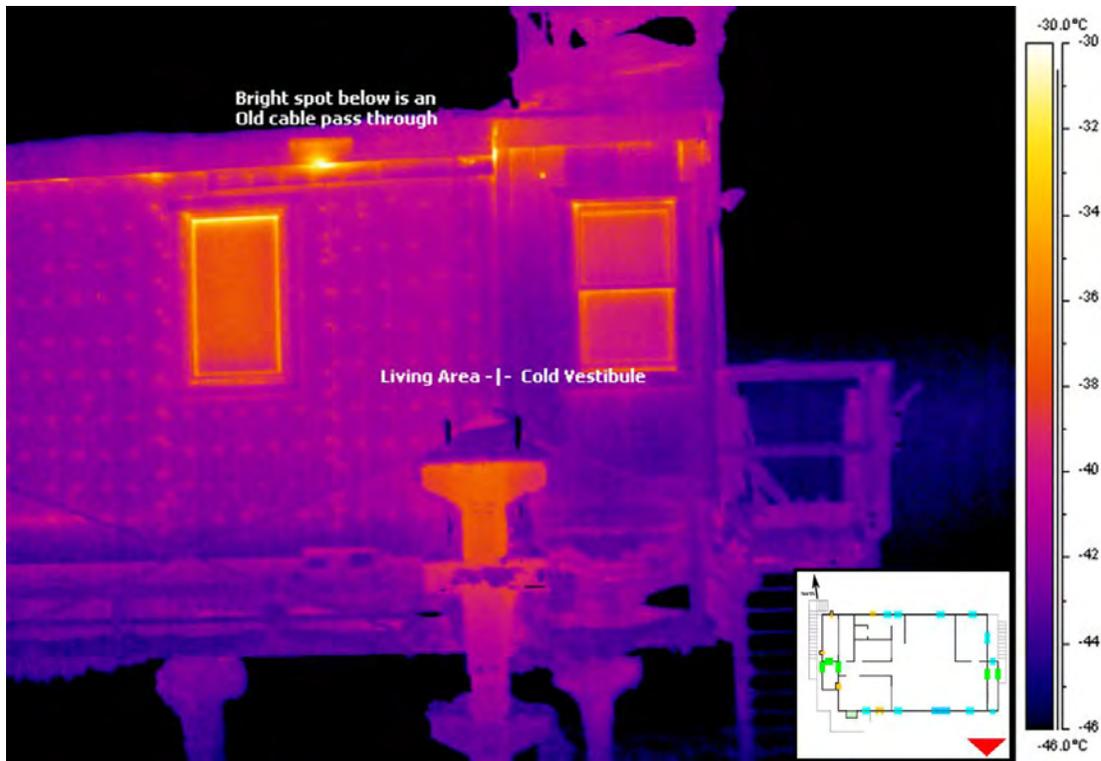
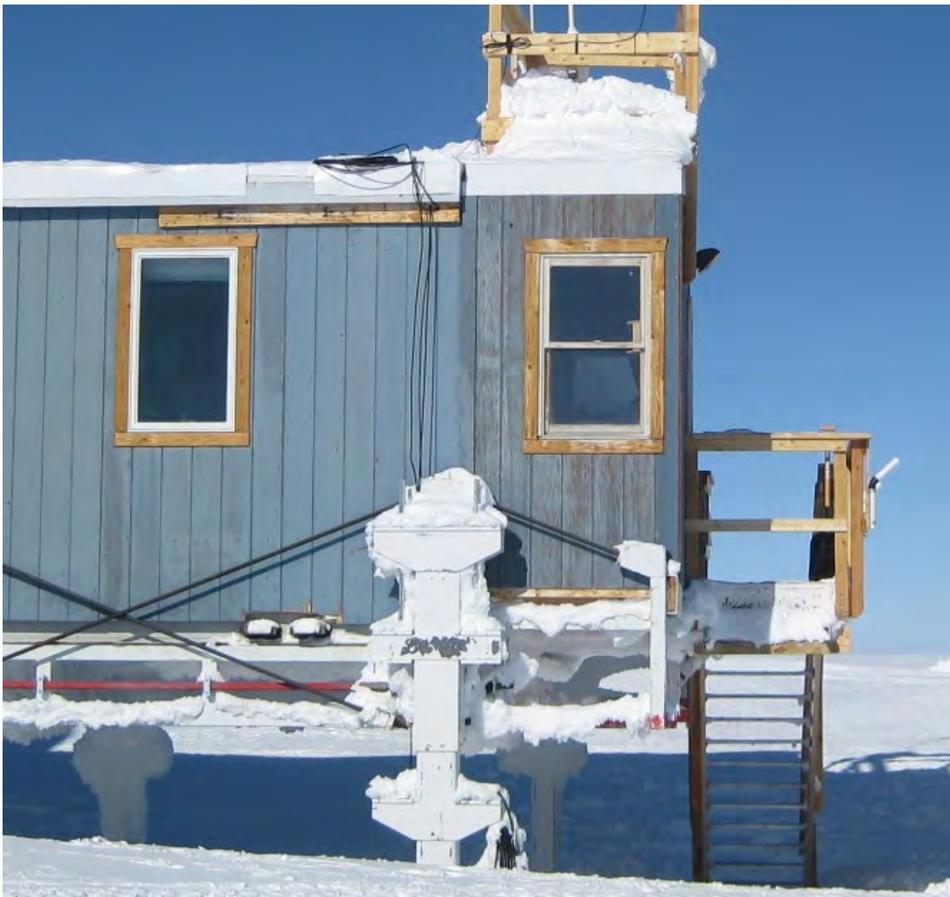
Along the eave are two bright spots showing heat loss from penetrations where previous instrumentation was mounted to the exterior (to the right of the main room window) and existing cables' pass-through to the roof (at the common wall between the main room and vestibule). The area on the right was sealed from the interior prior to the ERDC-CRREL field visit. Re-insulating the empty cavity through the wall should be considered to completely seal the opening and reduce heat loss. Designated cable conduits through the building envelope should be considered to decrease the number of penetrations for cables. This also ensures that the opening can be properly insulated.

Figure 19. View 7 showing location (inset), thermal, and visual image of the eastern end of the South exterior wall in the vicinity of the main room and east vestibule.

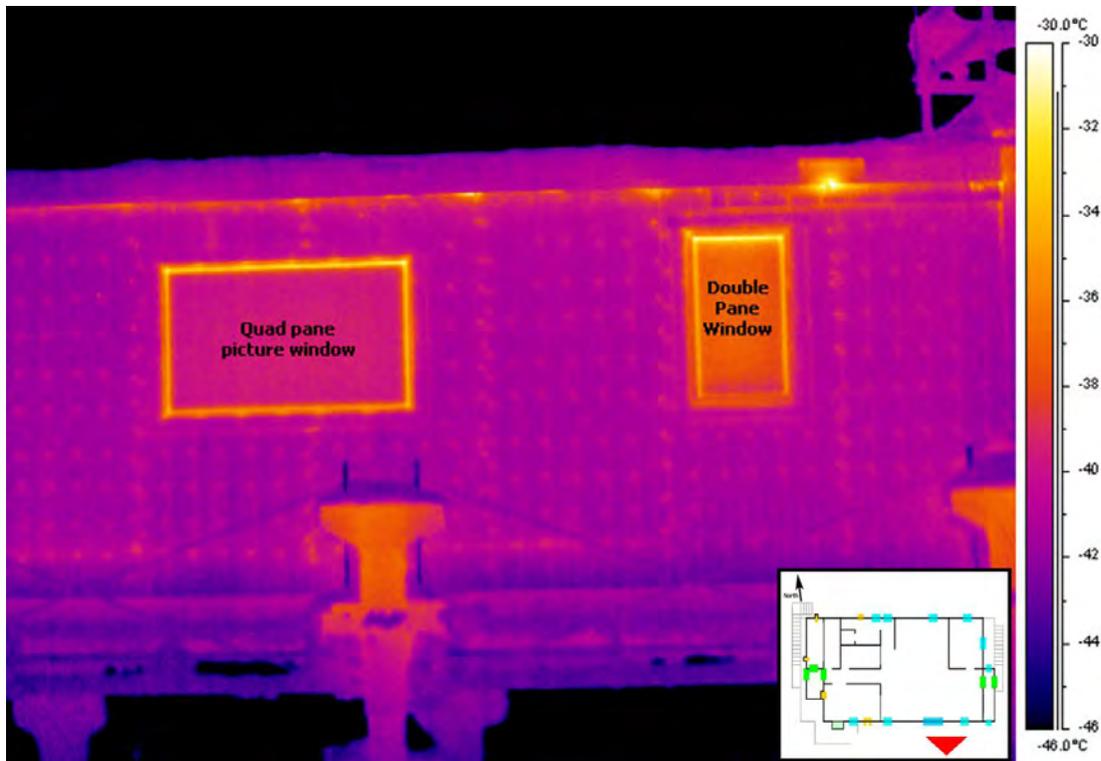
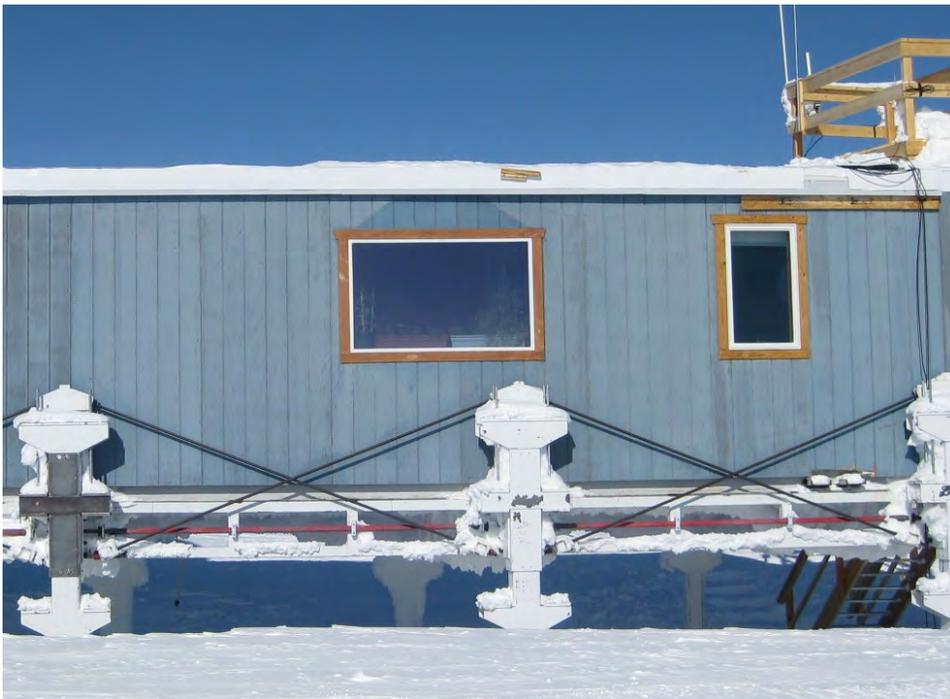
Both windows are the same type as the other casement windows previously mentioned and show similar characteristics in the IR image, with heat loss at the window header. The window on the right in the main room shows additional heat loss, and has about a 5°C temperature difference at the four bright spots under the window. This heat loss may be associated with the installation of the window, possibly ascribable to the counter on the interior that blocks the very bottom portion, or degradation of the window over time from moisture.

Figure 20. View 8 showing location (inset), thermal, and visual image of the South exterior wall in the vicinity of the main room.

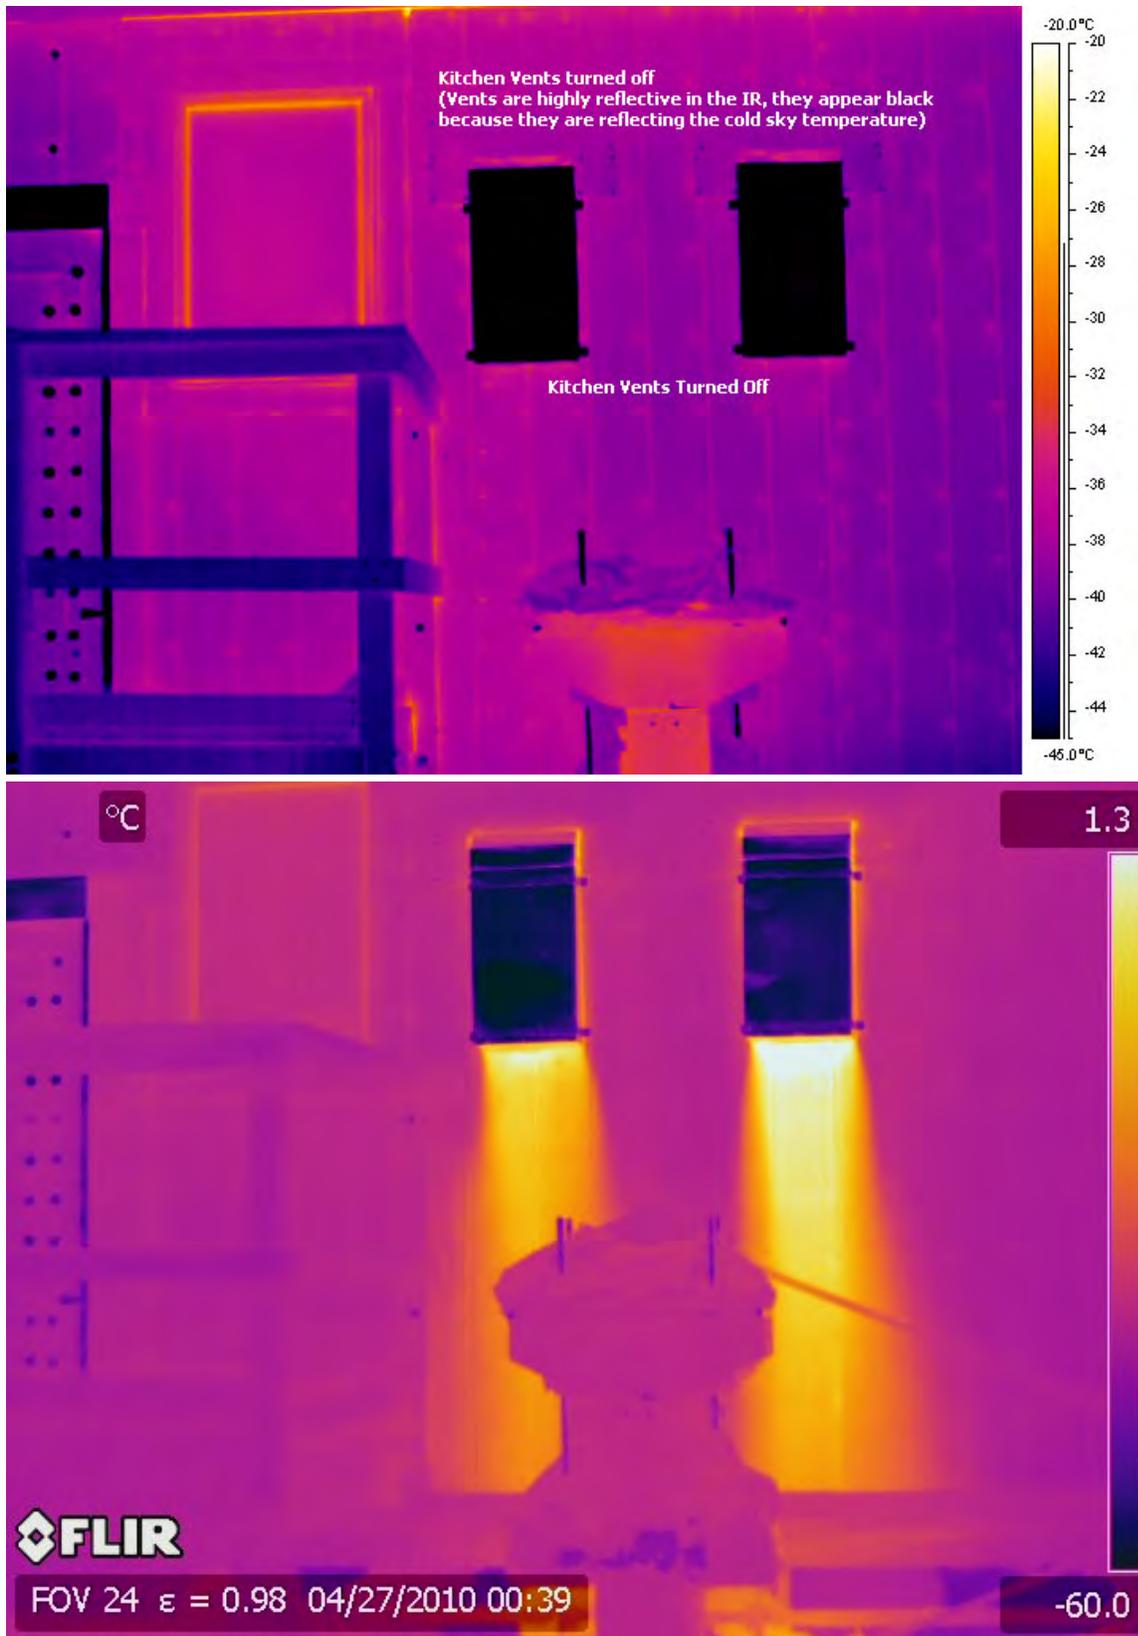
IR imagery taken from the outside of the Big House shows the impact of stove vents expelling warm air to the outside. Conversely, when the vents are not in use, cold air infiltrates the building through the vents.

Figure 22. Thermal image taken before and during stove vent operation.

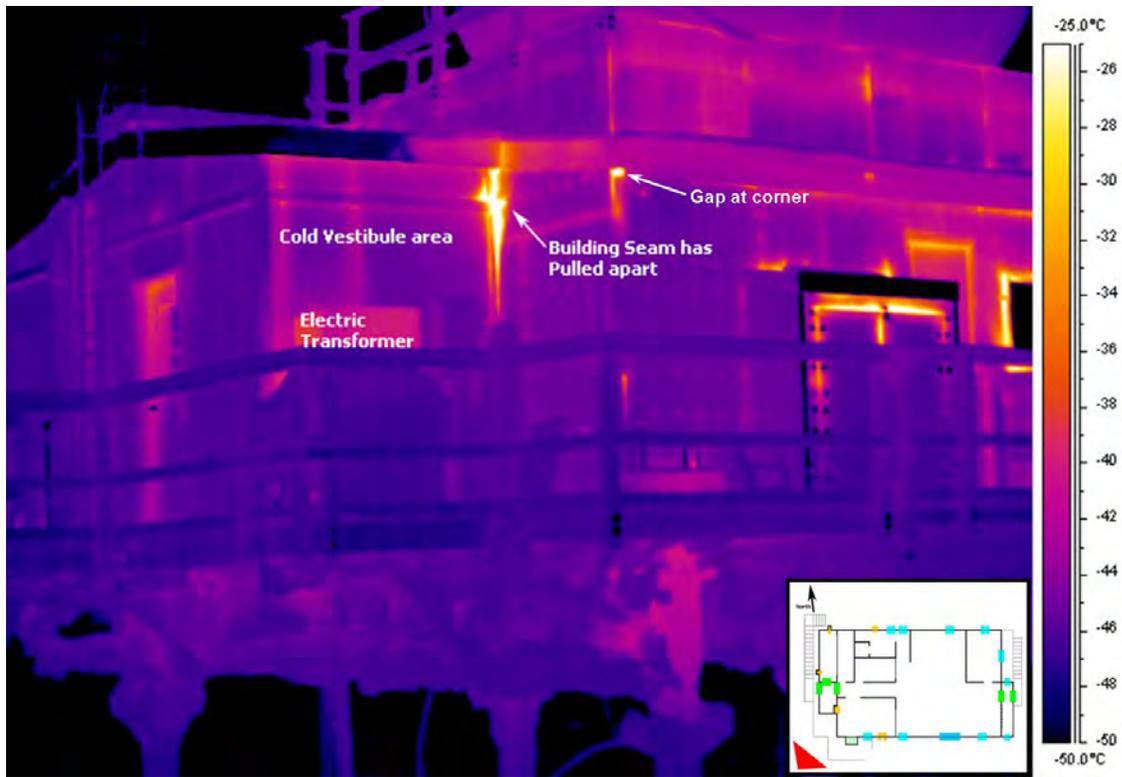
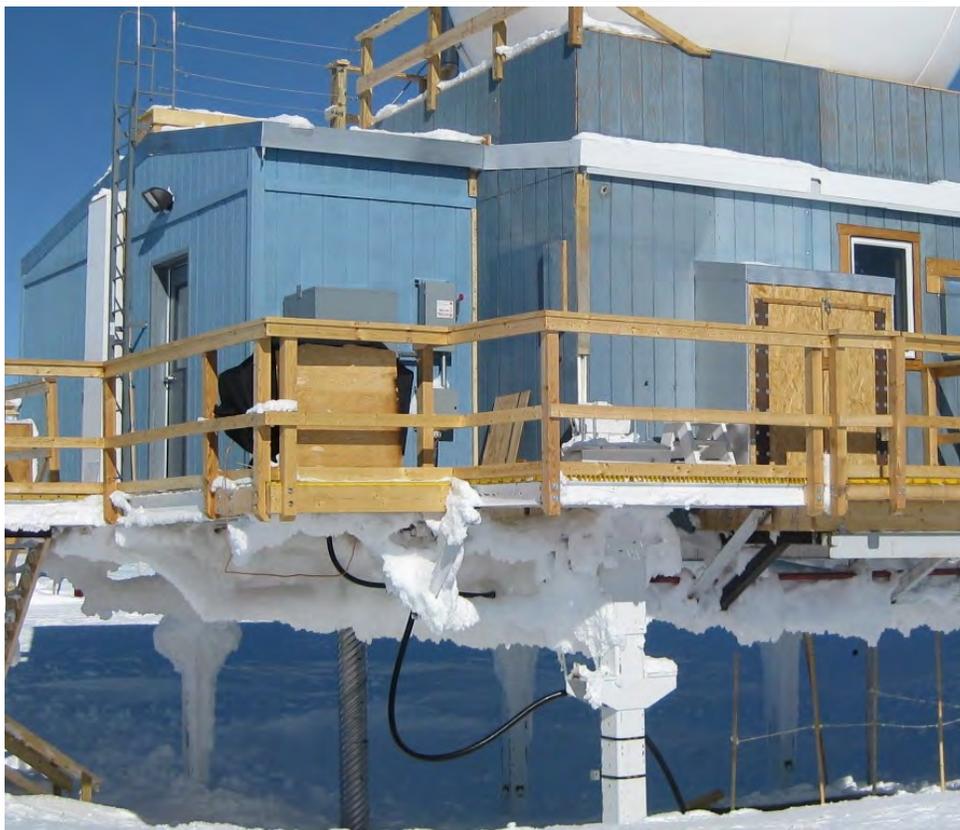
The southwestern corner of the building is shown in **View 12** (Fig. 24) where the west unheated vestibule connects to the main building. The southern portion of the vestibule contains shelving for dry goods and also houses the 600- × 600-mm fresh air intake into the kitchen. The very bright spot at the interface between the main building and the vestibule is a gap indicating excessive heat loss. Further to the right, at the corner of the main building, the bright spot there is from a gap at the eave created when the building was re-sheathed (Fig. 25).

Figure 24. View 12 showing location (inset), thermal, and visual image of the of the southwest corner where the west vestibule connects to the main building

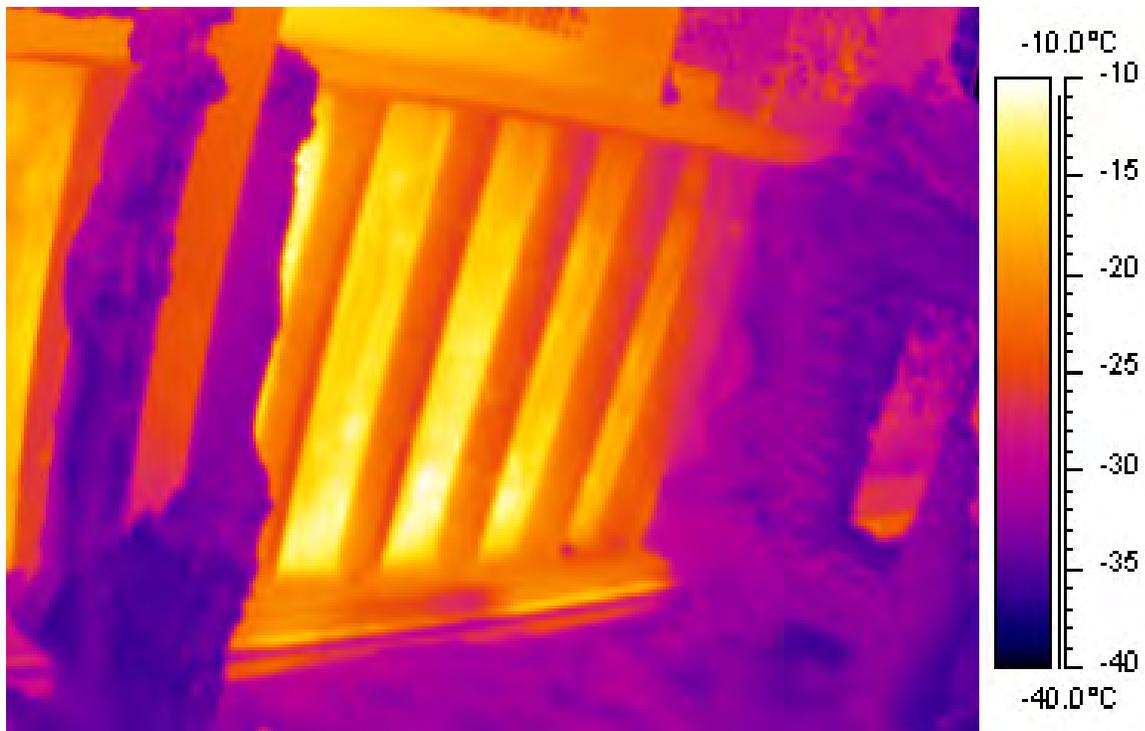
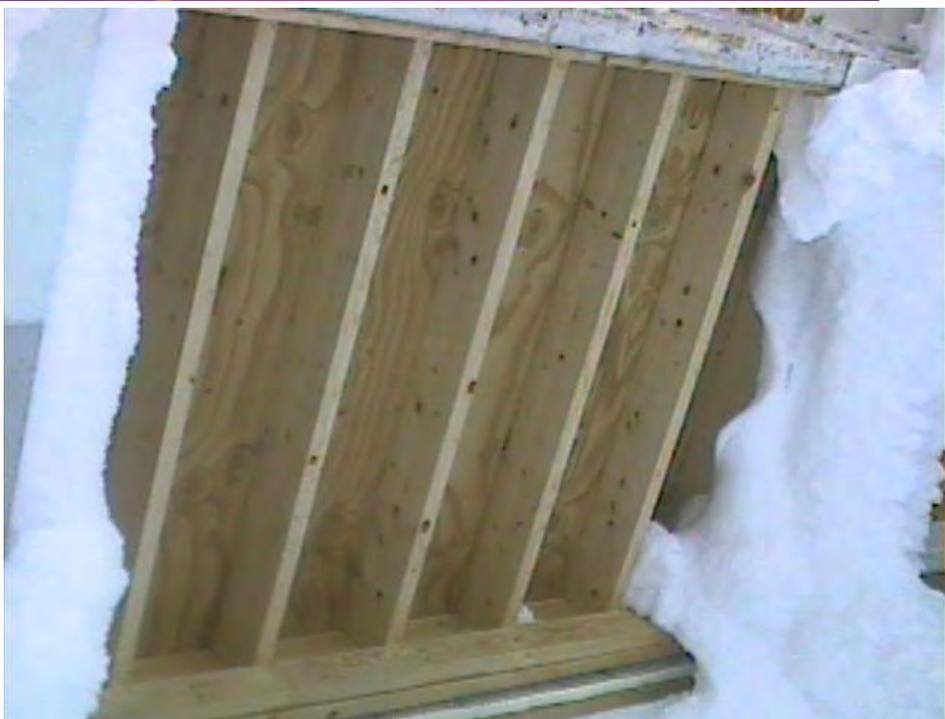
Figure 29. View showing thermal and visual image of heat loss through base of unheated eastern vestibule.

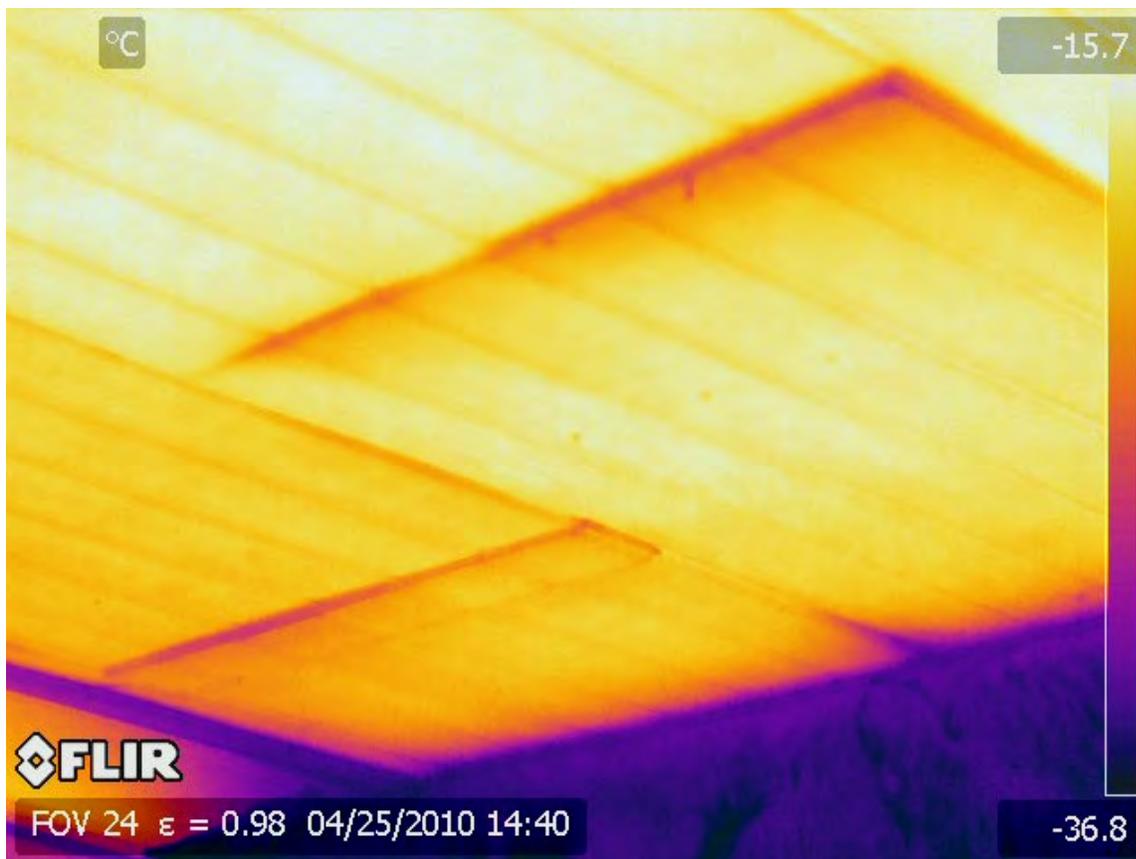
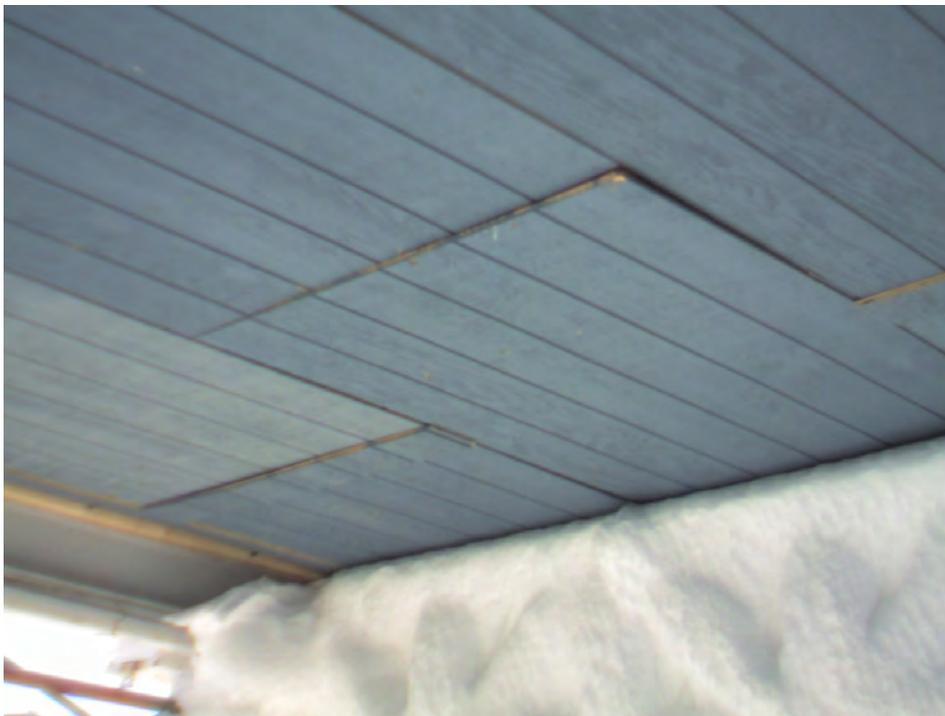
The IR imagery of the exterior base of the structure did not show significant heat loss through the floor. Other than open active vents, the blocked-off vent in the floor of the mechanical room was the only bright spot in the IR imagery. Several pieces of loose sheathing on the underside of the building should be reattached.

Figure 30. View showing thermal and visual image of unsecured sheathing on base of building.

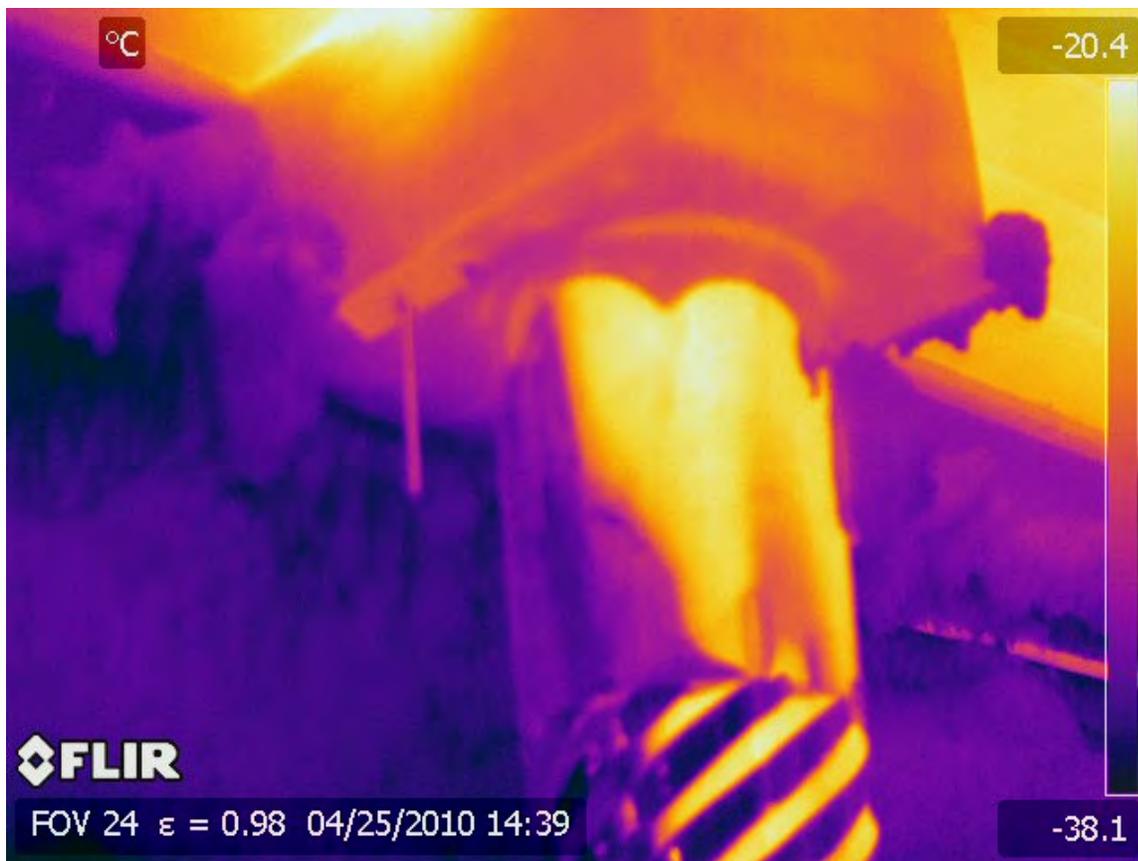
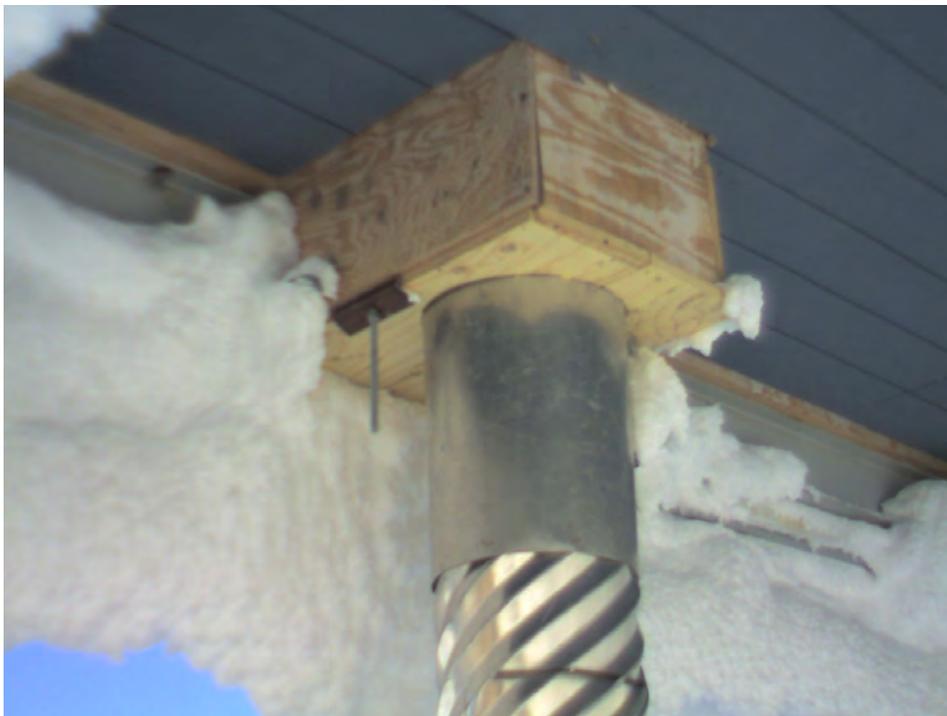
Lastly, Figures 31 and 32 show IR and visual images of the sewer outfall pipe and the opening of the fresh air intake vent in the kitchen, respectively. The sewer outfall pipe shows some heat loss at the interface between the housing around the pipe and the base of the building. Likewise, there is heat loss from the kitchen through the air intake vent.

Figure 31. Base of the building, IR and visual images of the sewer outfall pipe.
