Engineering Assessment of Big House at Summit Station, Greenland

Final Report

Lynette A. Barna, Keran J. Claffey, James S. Buska,
and Jennifer L. Mercer

April 2011

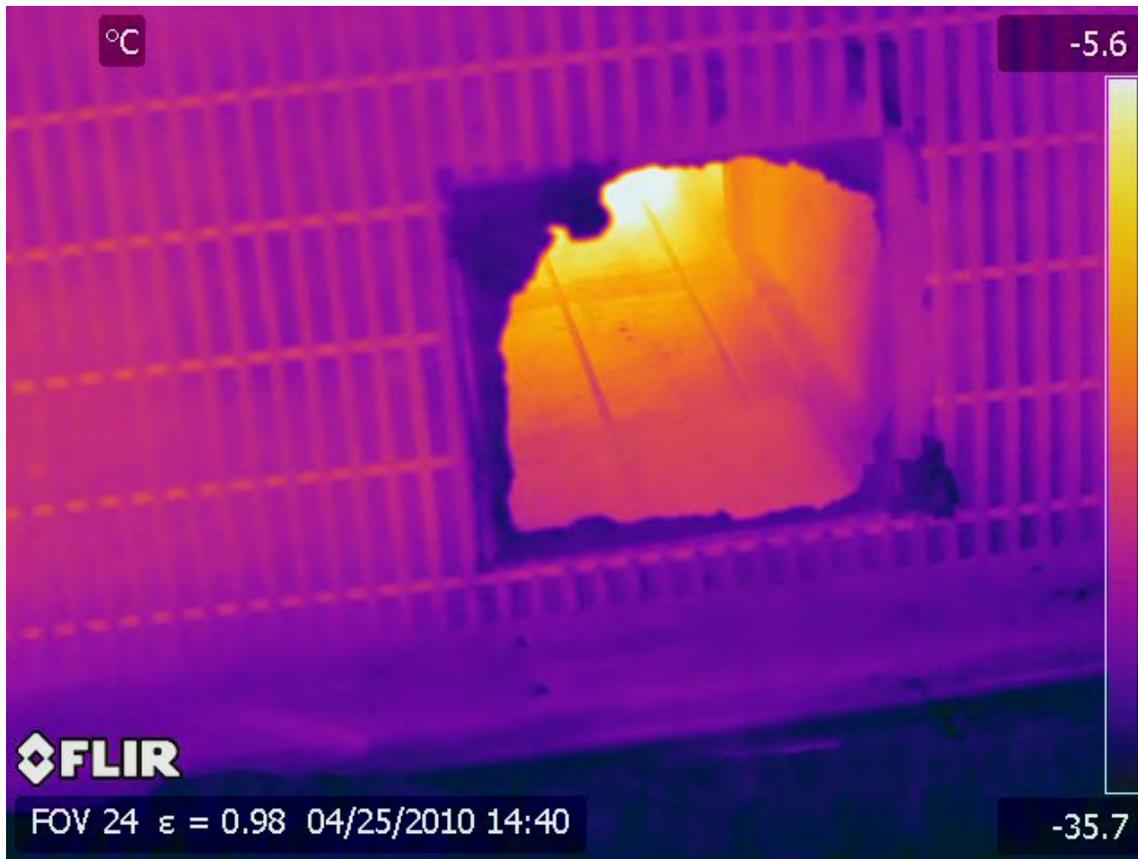
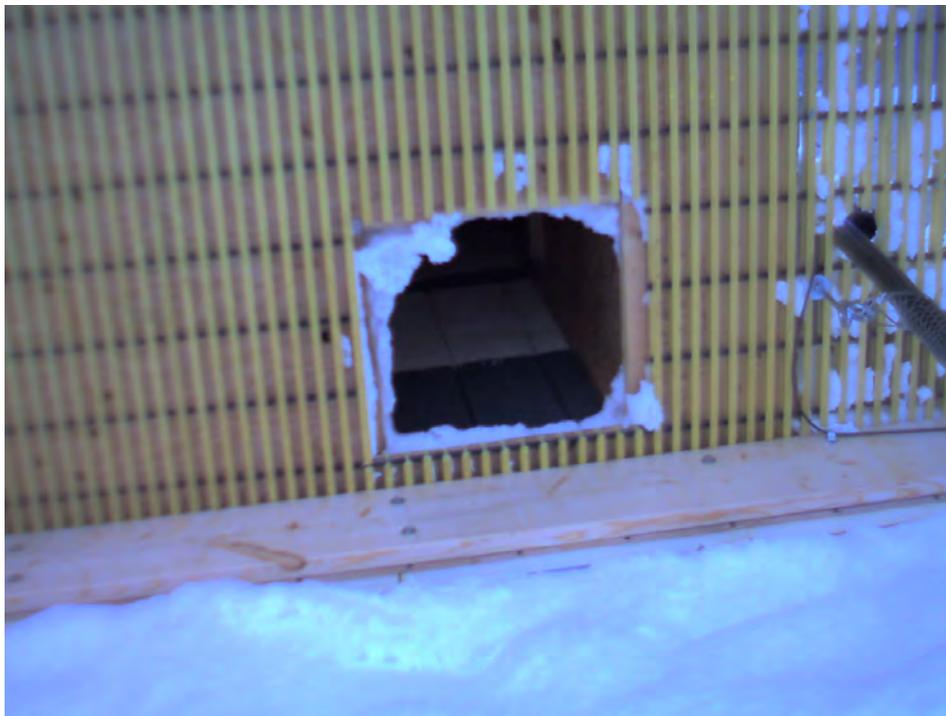
Lastly, Figures 31 and 32 show IR and visual images of the sewer outfall pipe and the opening of the fresh air intake vent in the kitchen, respectively. The sewer outfall pipe shows some heat loss at the interface between the housing around the pipe and the base of the building. Likewise, there is heat loss from the kitchen through the air intake vent.

Figure 32. Base of the building, IR and visual images of the kitchen air intake vent.

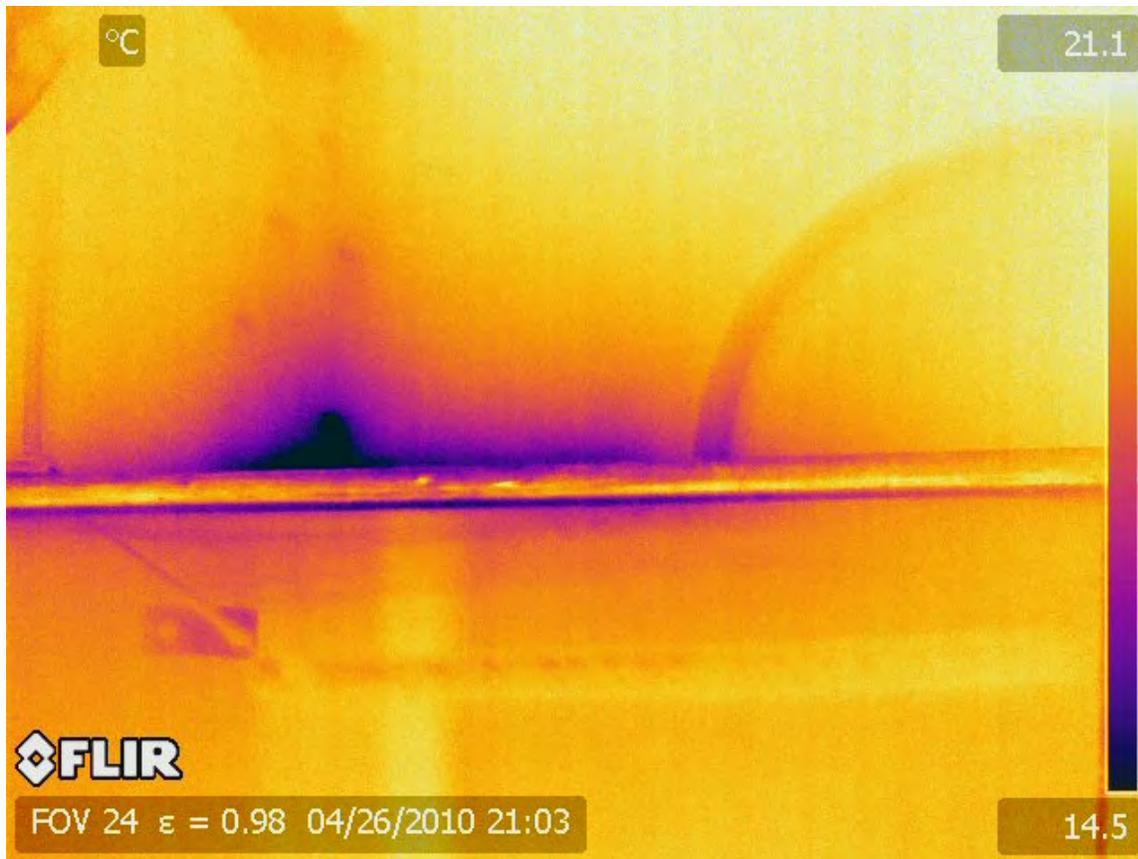
Also seen in Figure 35 is the sealant used around roof beams and along the roof-wall interface. This keeps the moisture from migrating through the wall.

Figure 35. IR and visual images of the roof-wall interface behind the stove in the kitchen.

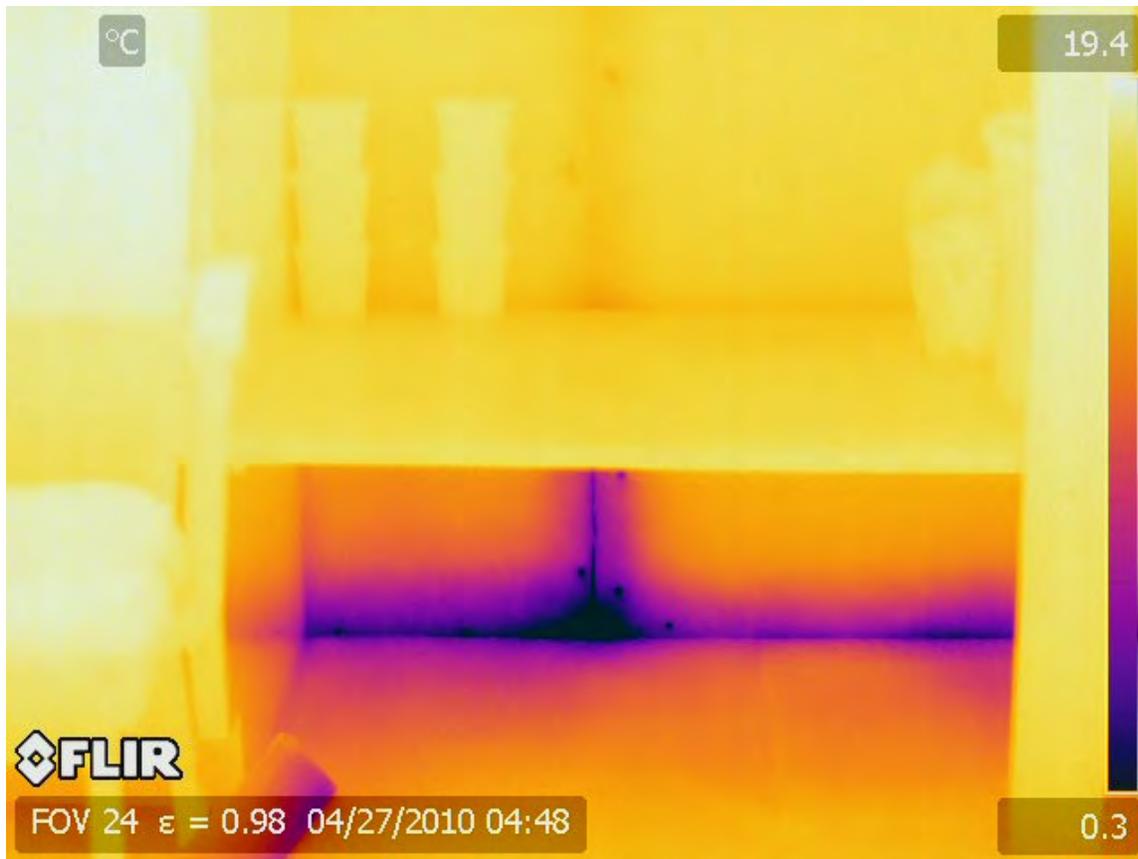
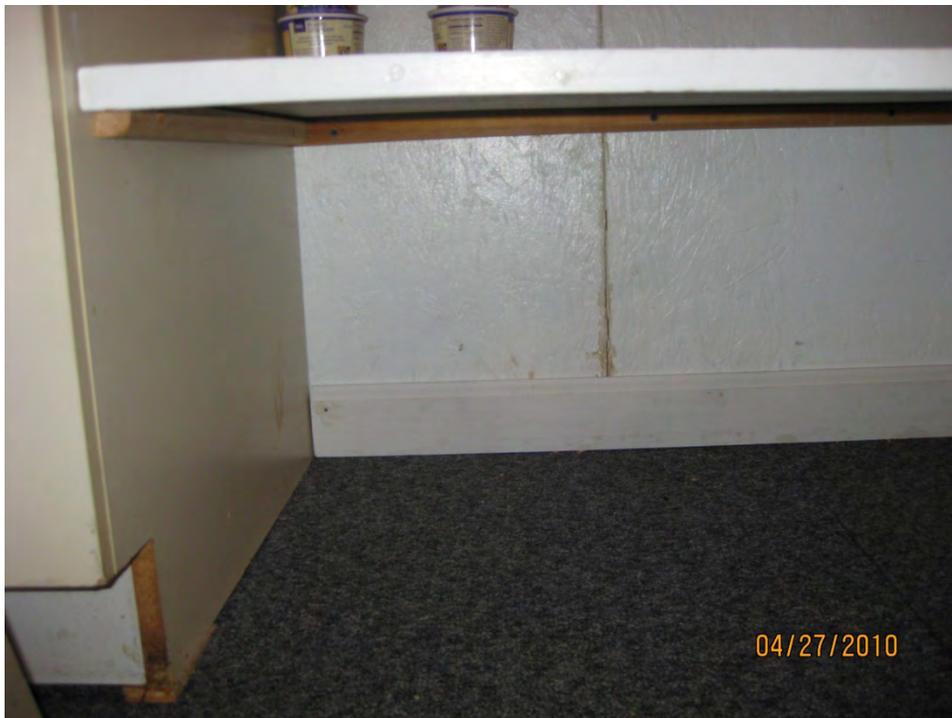
Figure 36. IR and visual images of the cold location under the counter in the main room before it was sealed.

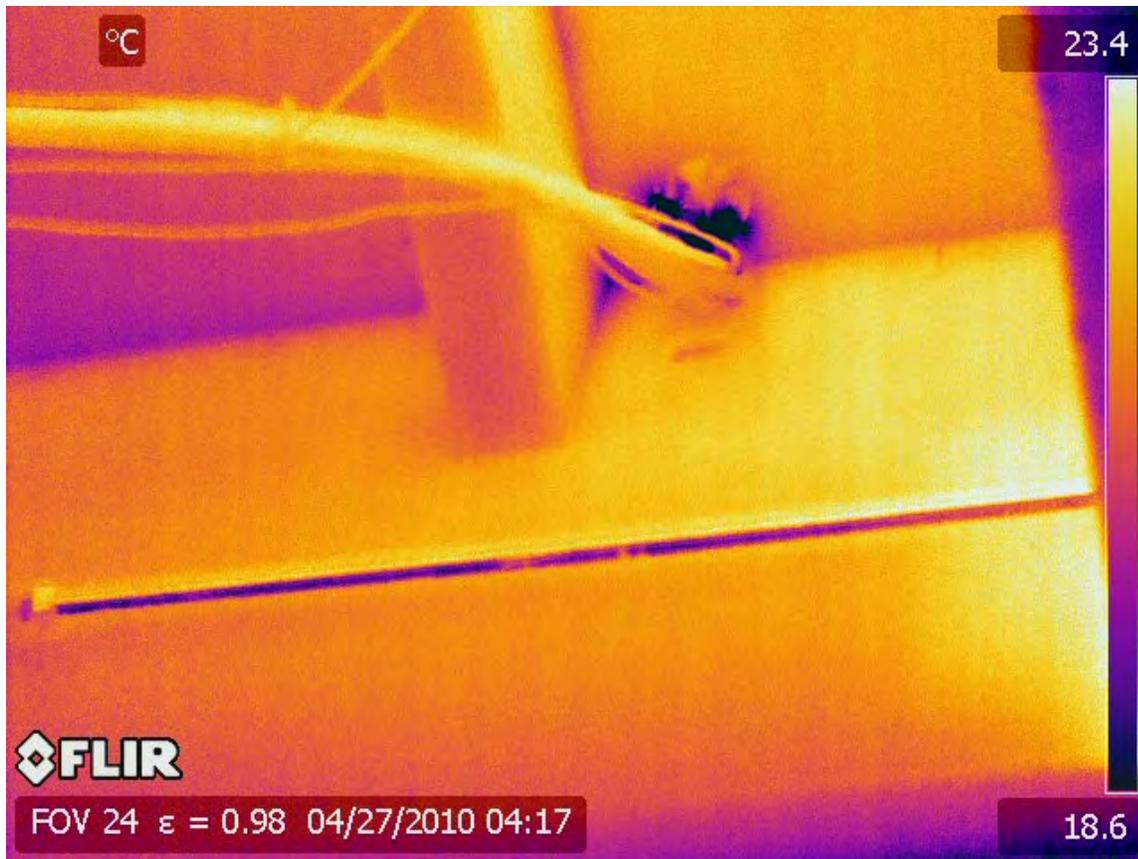
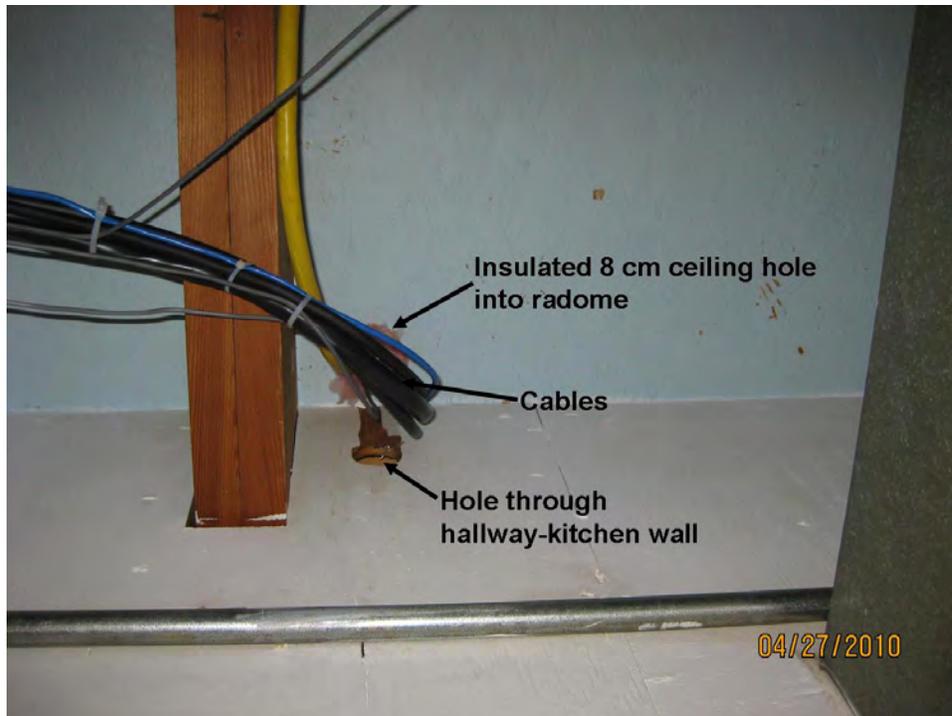
The radome on the roof was not observed to be a significant contribution to heat loss. However, there is some heat loss from the inside of the Big House where the cables run through the ceiling up into the radome.

Figure 38. IR and visual images of the ceiling in the hallway where cables pass through into the radome.

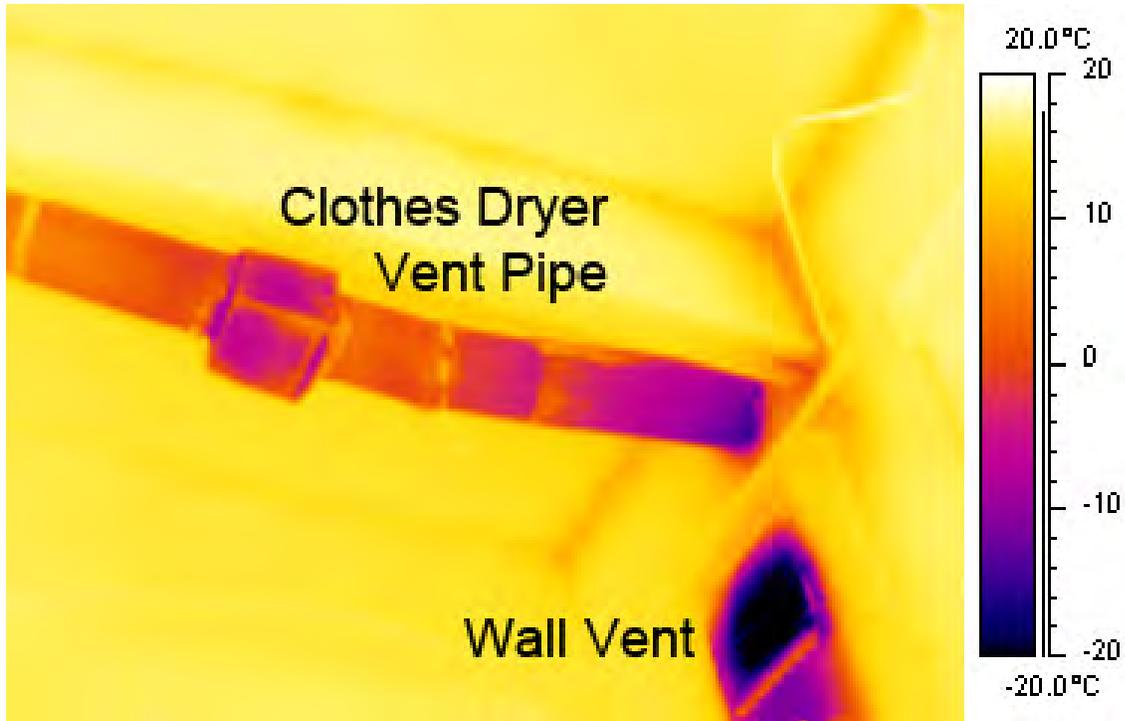
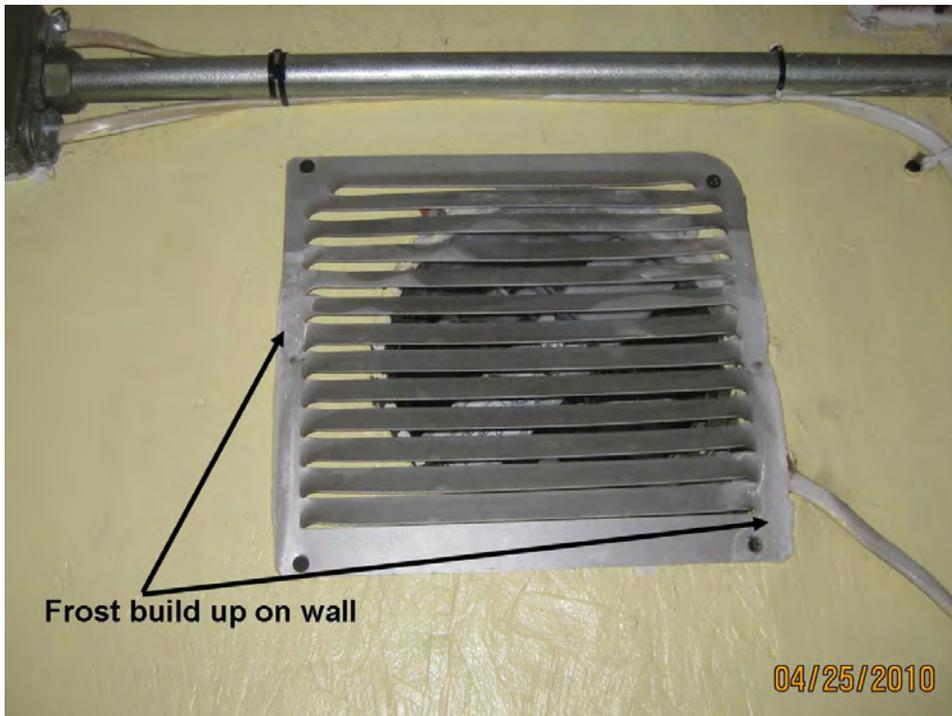
At the time of the IR survey, an air vent centrally located on the north wall in the laundry room was a direct pathway for cold air to infiltrate into the building. This through-the-wall vent is no longer an issue as it was removed later during the 2010 summer season. The hole was insulated and sealed (CPS 2010). Another possible solution would be to relocate this vent to an internal location, such as the wall between the laundry room and scullery, or the wall between the laundry room and hallway. Moving this warm, moist air within the Big House would serve to disperse the humidity where it is needed into the main room. This would also alleviate the ice buildup on the north exterior wall.

Figure 41. IR image of both the clothes dryer and through-wall vent in the laundry room/bathroom. The visual image is a closeup of the through-wall vent noting frost buildup from cold air infiltration.

- Use durable exterior hardware should to ensure a proper seal. A direct vent in the north wall of the laundry room created a pathway for cold air infiltration. This vent was removed and the hole insulated and sealed during the 2010 summer season. For through-wall vents, durable exterior hardware should be used to ensure a proper seal when the vent is not in use. Another possible solution would be to relocate this vent to an internal location, such as the wall between the laundry room and scullery, or the wall between the laundry room and hallway. Either of these locations would serve to move this warm, moist air within the Big House to disperse the humidity where it is needed into the main room, and this would also alleviate the ice buildup on the north exterior wall.

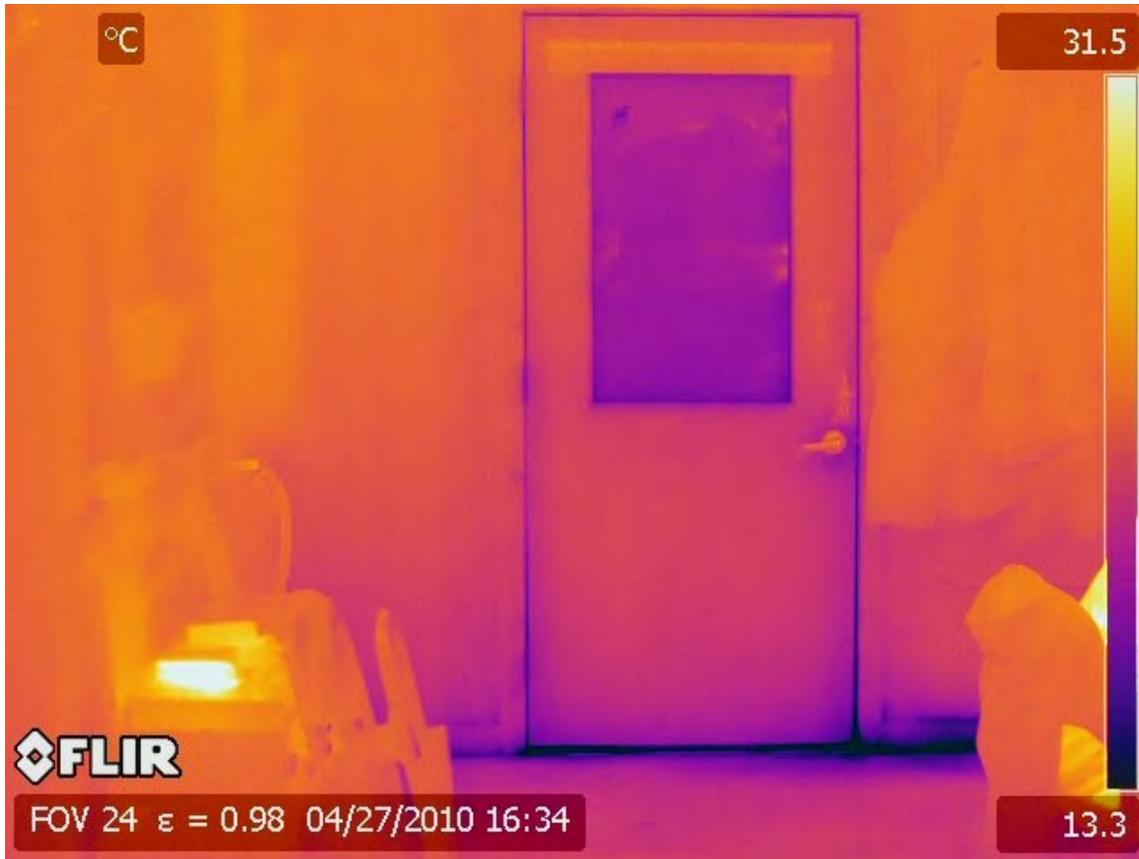
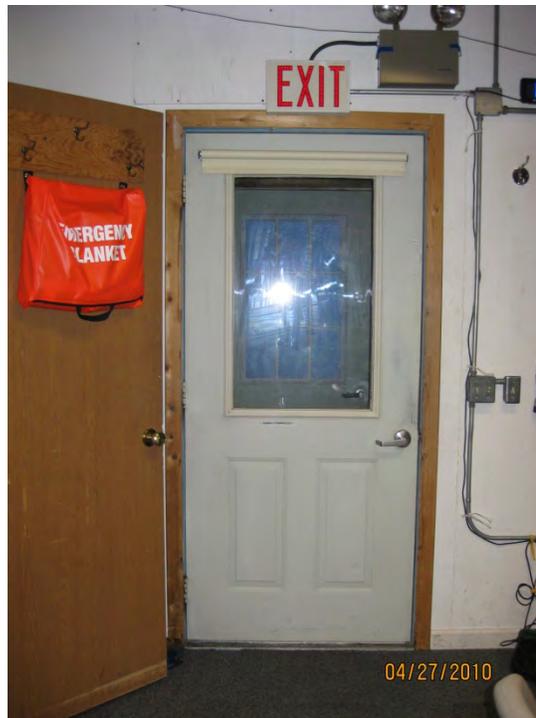
The IR imagery shows heat loss around both the east and west vestibule exterior doors, likely from wear on the door seal, as well as through the window. Both of these doors are insulated residential doors with a viewing window in the upper half of the door.

Figure 42. IR and visual images of the main entrance door in the east vestibule.

- Reduce heat loss around the exterior doors in both the east and west vestibules by replacing the seals.
- Remove the windows in the east vestibule if they are not necessary. This will reduce moisture buildup. Another method to reduce the amount of moisture buildup in arctic entryways is to maintain a constant low temperature (between 2 and 5°C) to mitigate the large temperature swings in an unheated vestibule.

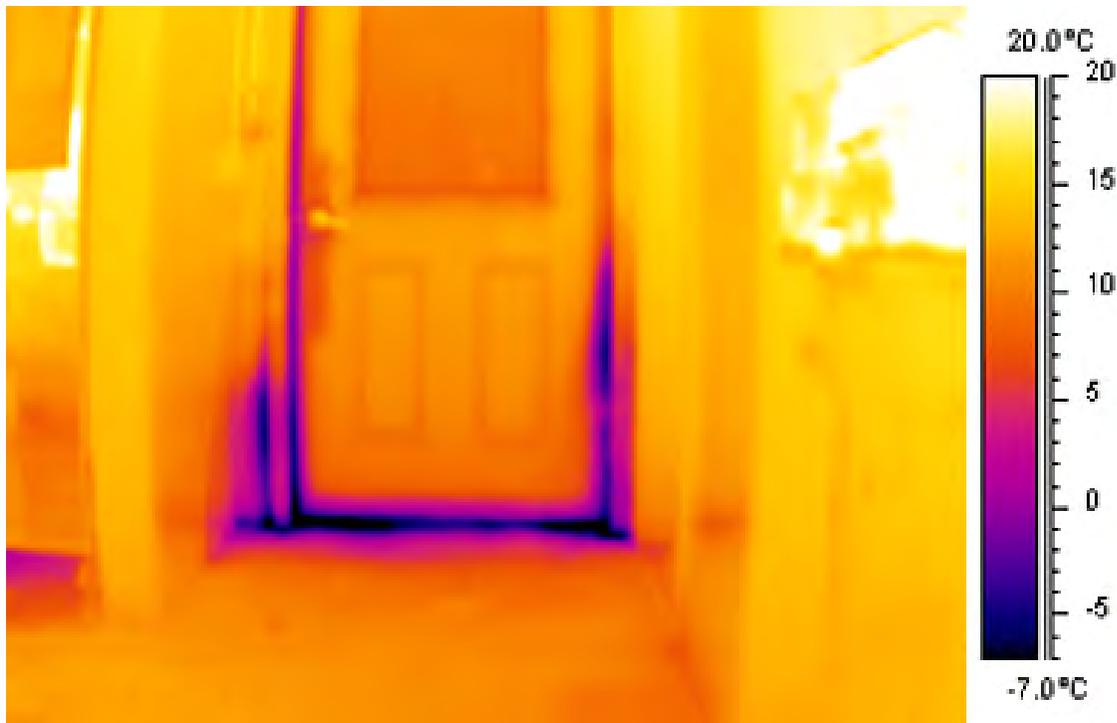
Figure 43. IR and visual images of the main entrance door in the west vestibule.
