Engineering Assessment of Big House at Summit Station, Greenland

Final Report

Lynette A. Barna, Keran J. Claffey, James S. Buska,
and Jennifer L. Mercer

April 2011

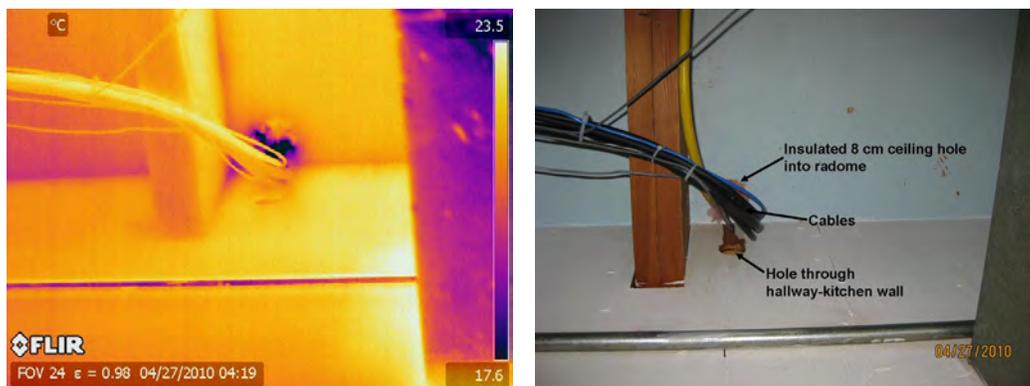
Figure S-5. Well insulated cable pass-through into radome.

Similarly, more heat loss was observed along the south side fascia, particularly toward the eastern end of the building, where instruments had previously been installed and in locations where repairs had been made to the metal flashing. Figure S-4 illustrates the heat loss observed in the IR imagery from the south side eastern end of the building. The cable pass-through to the radome (Fig. S-5) is an example where the cable pass-through is well insulated and little heat loss occurs.

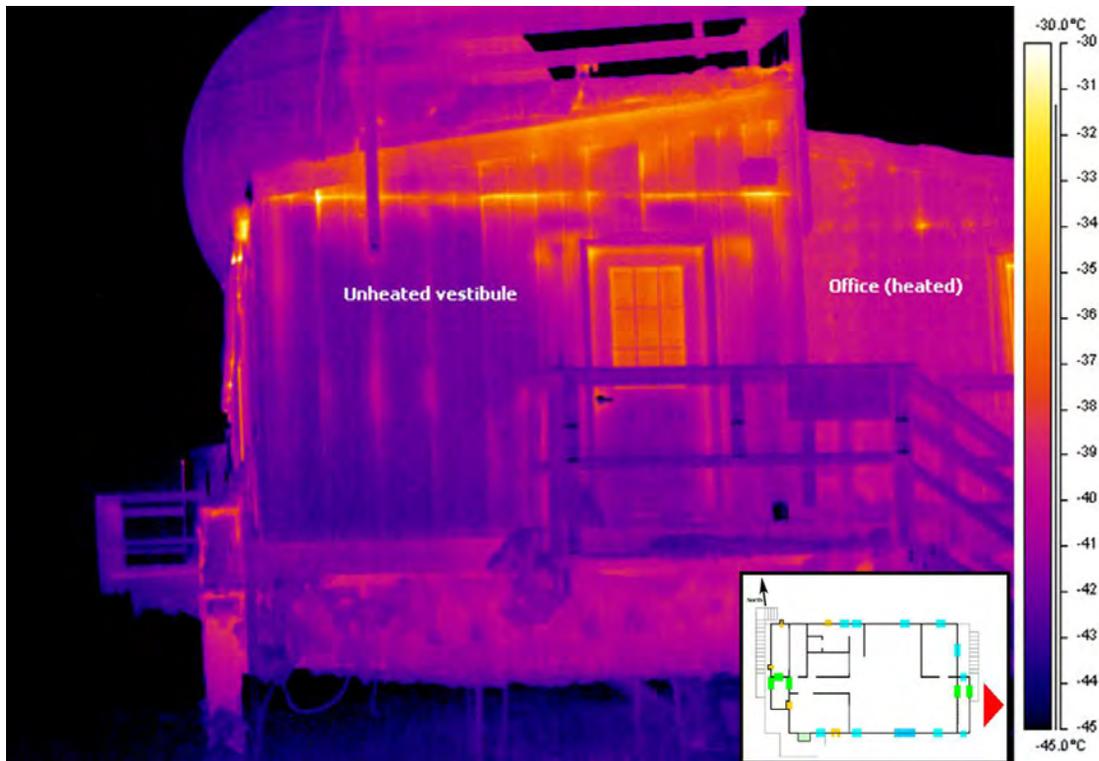
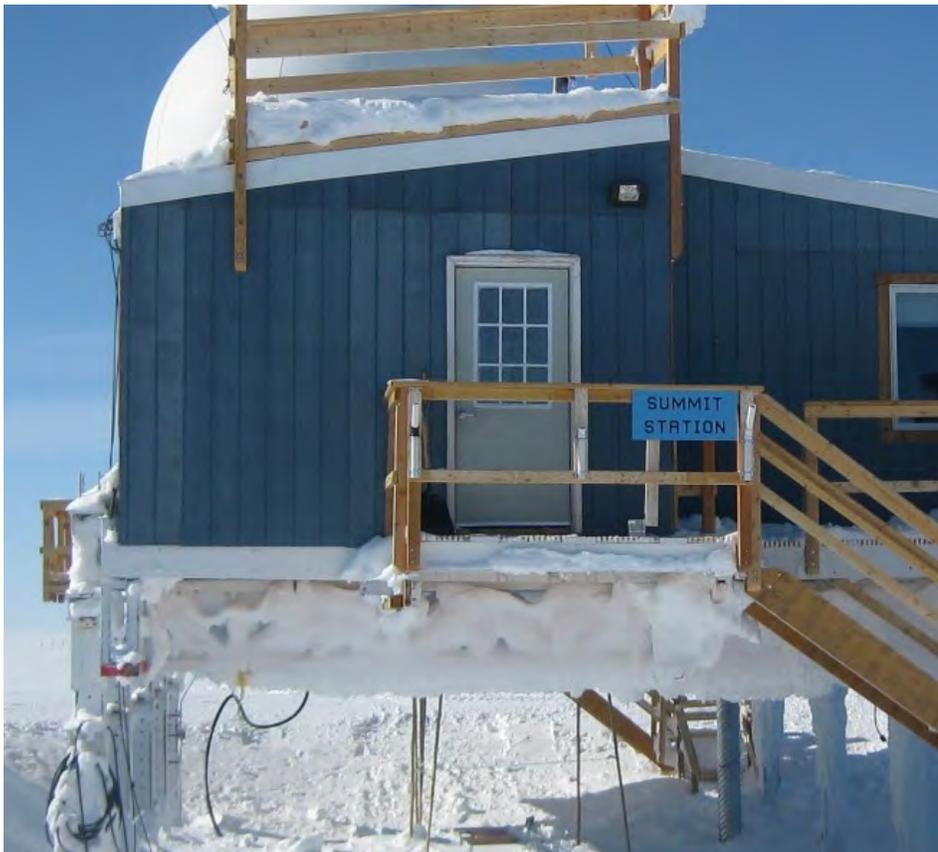
Figure 18. View 6 showing location (inset), thermal, and visual image of the eastern end of the Big House.

View 6, shown in Figure 18, is the southern portion of the eastern end of the Big House, and highlights the unheated entry vestibule. Again, the bright horizontal line at the interface of the T-111 siding indicates heat loss from the upper ceiling of the vestibule. The ceiling in the vestibule is open and slanted. The access hatch to the roof is located in the ceiling of the vestibule. During the visit, there was a substantial amount of frost built up on the access hatch on the inside of the vestibule.

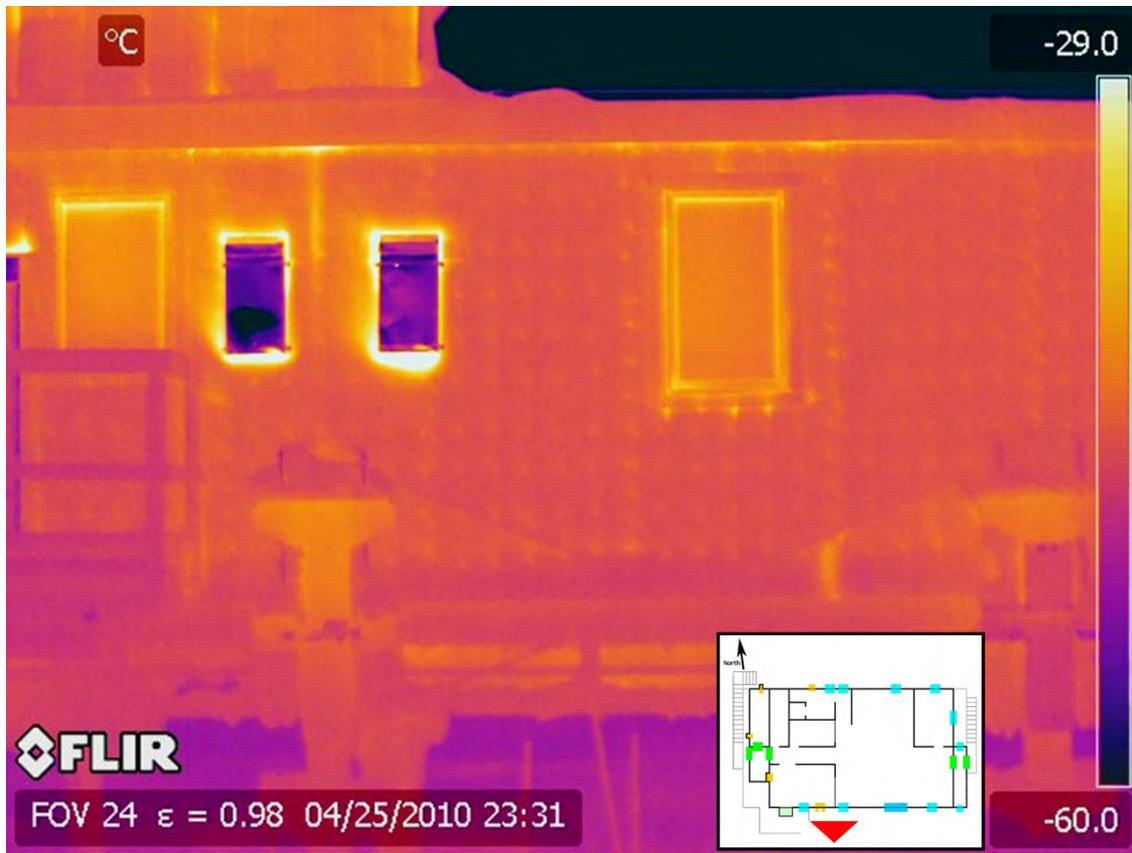
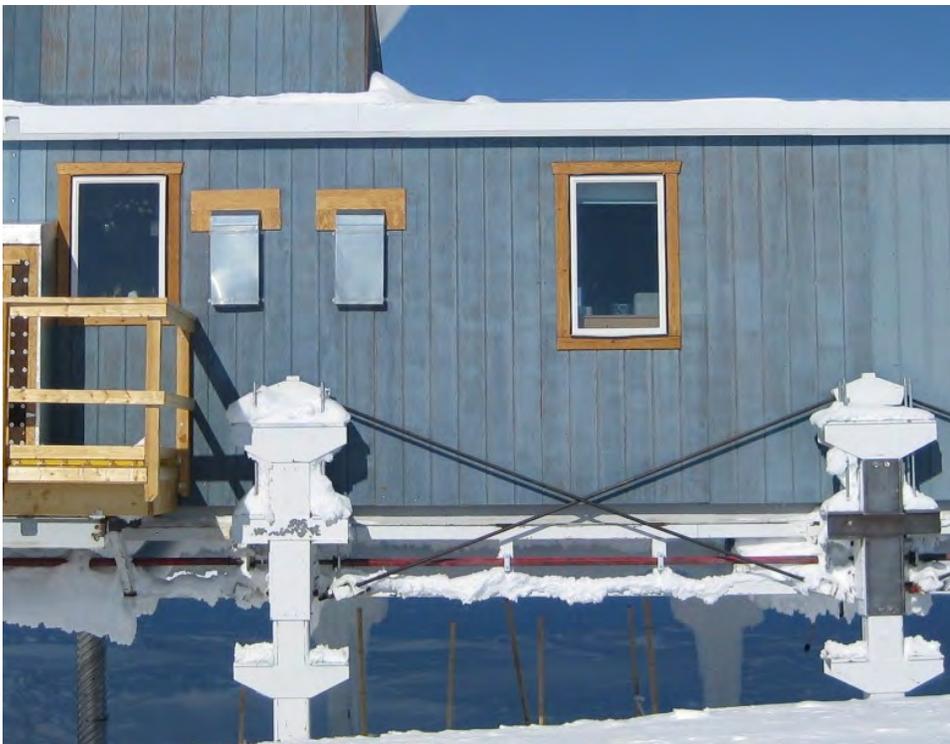
The images in **View 10** (Fig. 21) include the kitchen stove vents and double-pane window (left) and the double-pane window in the main room dining area (right).

Figure 21. View 10 showing location (inset), thermal, and visual image of the south exterior wall in the vicinity of the kitchen.

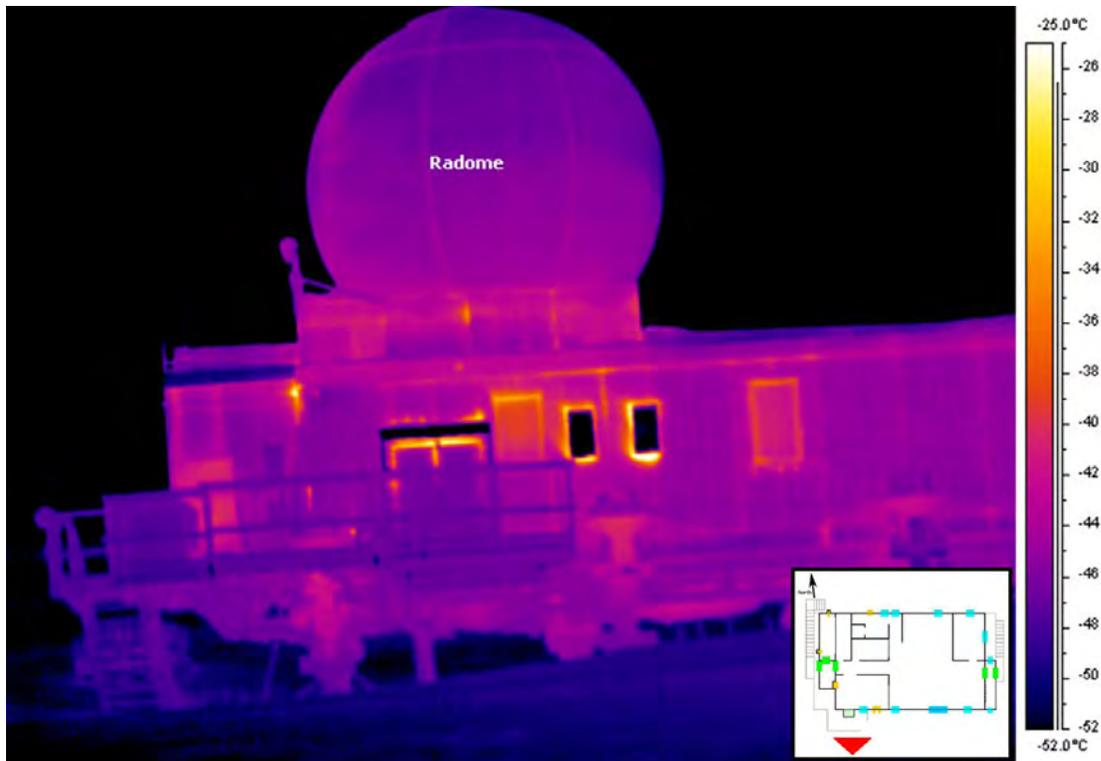
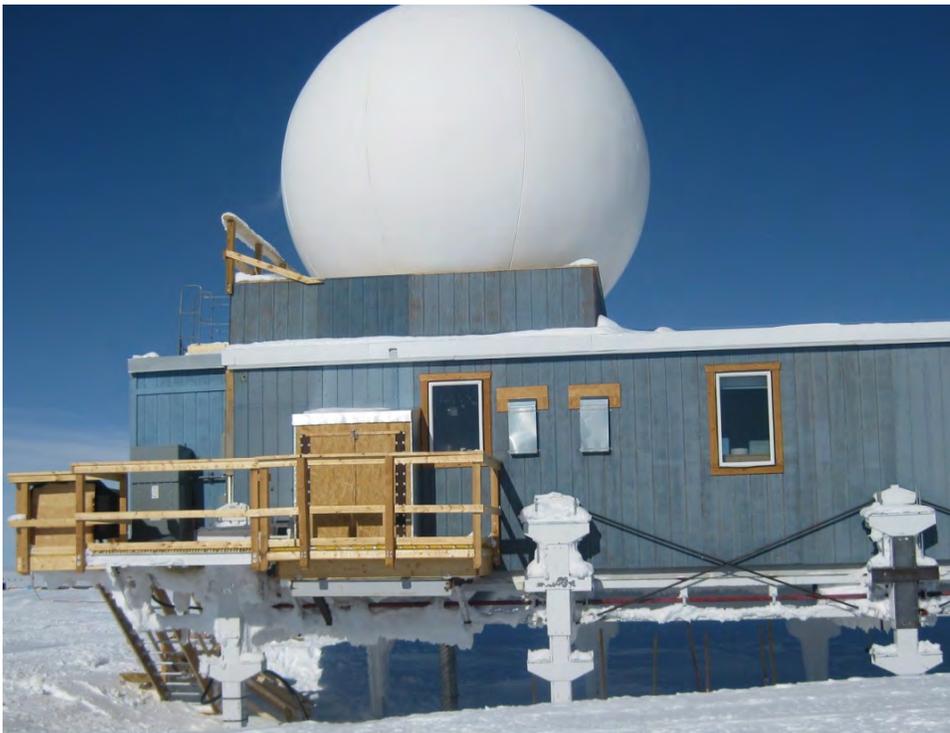
View 11 (Fig. 23) shows the western end of the south side exterior wall, including the radome on the roof. The top portion of the radome base is warmer than the bottom, and there is another warm spot at the roof eave. There is a small heat trace system installed in the radome to keep the instruments warm. The box structure that supports the radome may retain some of this heat. The top of the radome is cold, suggesting that there is not an excessive amount of heat loss. While there is a small heat leak at the base of the radome, it is not a significant amount. On the ceiling inside the Big House are bolts that attach through the roof SIPs that secure the base of the radome. These images indicate some, but not a significant amount of, heat transfer along the bolts. Also shown in this IR image is the propane storage area (center of image, double-door behind deck railing) that shows some heat loss from the heater that maintains a suitable propane temperature. Improving the gasket around the storage doors would reduce this.

Figure 23. View 11 showing location (inset), thermal, and visual image of the of the south exterior wall west end in the vicinity of the kitchen.

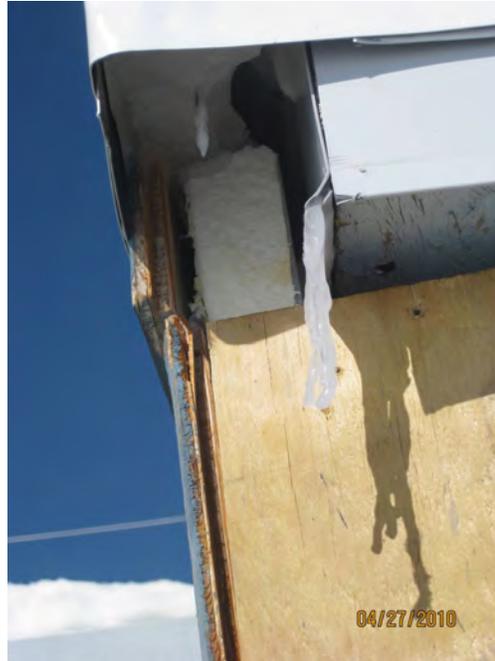
The southwestern corner of the building is shown in **View 12** (Fig. 24) where the west unheated vestibule connects to the main building. The southern portion of the vestibule contains shelving for dry goods and also houses the 600- × 600-mm fresh air intake into the kitchen. The very bright spot at the interface between the main building and the vestibule is a gap indicating excessive heat loss. Further to the right, at the corner of the main building, the bright spot there is from a gap at the eave created when the building was re-sheathed (Fig. 25).

Figure 25. Closeup of the southwestern corner of the original main building showing the gap between the materials of the original exterior and the recent re-sheathing.

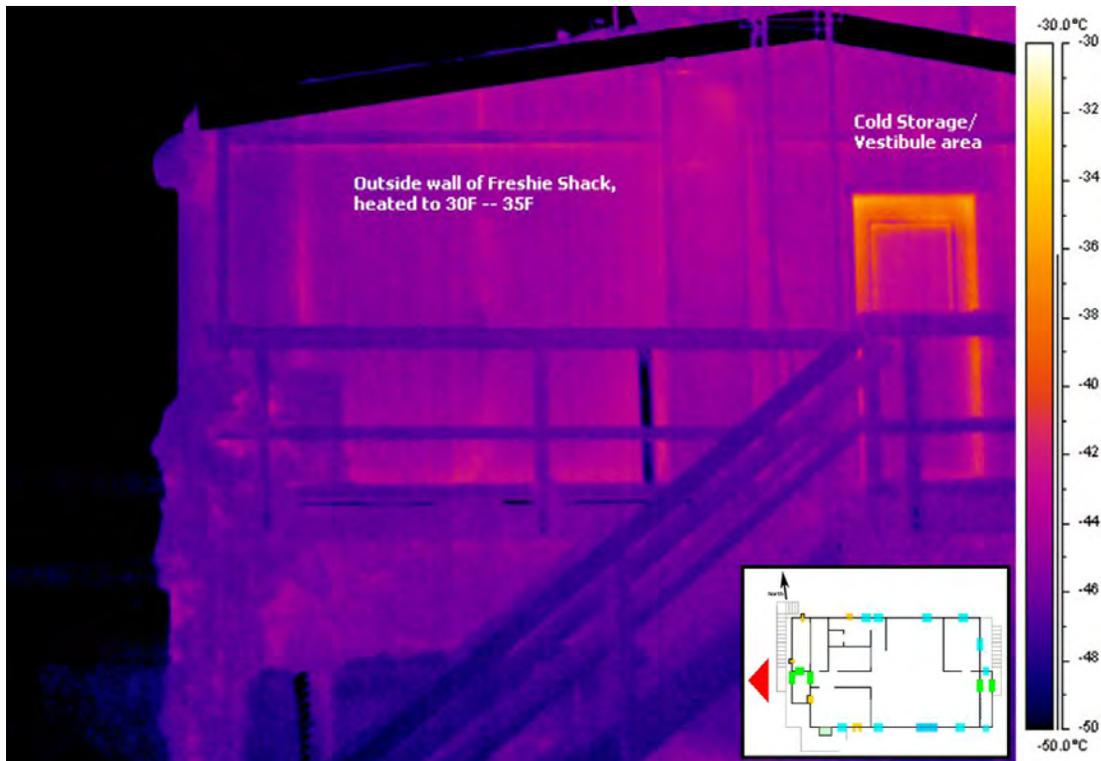
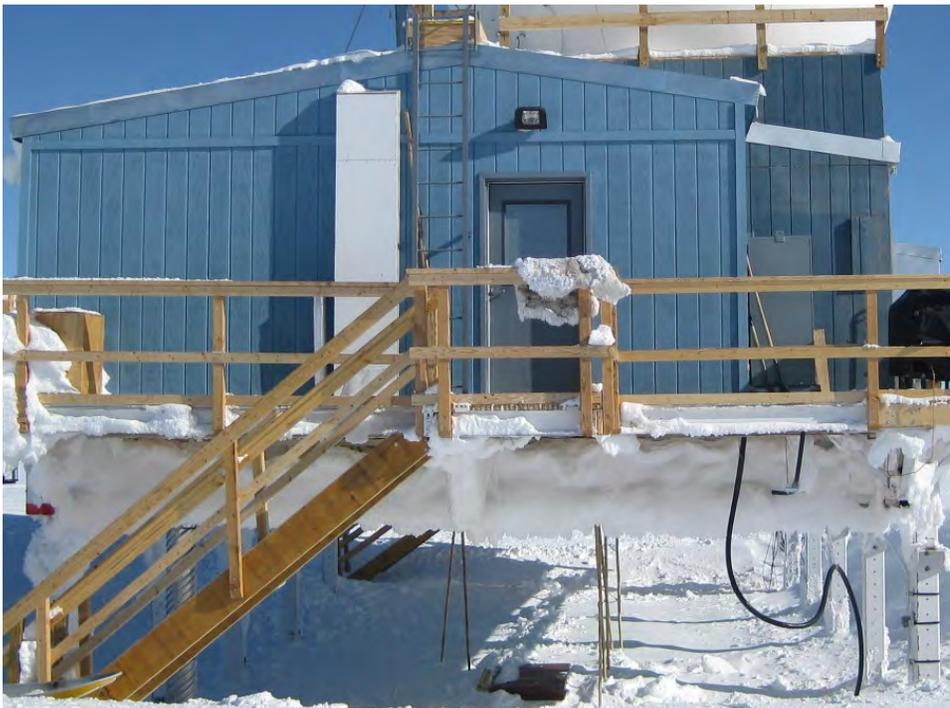
View 13, Figure 26 is a set of images showing the western end of the building. The vestibule is unheated and the freshie shack is located on the left side of the entrance. Heat loss is seen as the bright area along the top of the doorway. In the photograph, the white box (to the left of the doorway) is the vent for the summer intake fan into the freshie shack. It was covered with cardboard inside at the time of the IR survey. No significant heat loss is apparent.

Figure 26. View 13 showing location (inset), thermal, and visual image of the of the west end. The freshie shack is on the left side of the entry door.

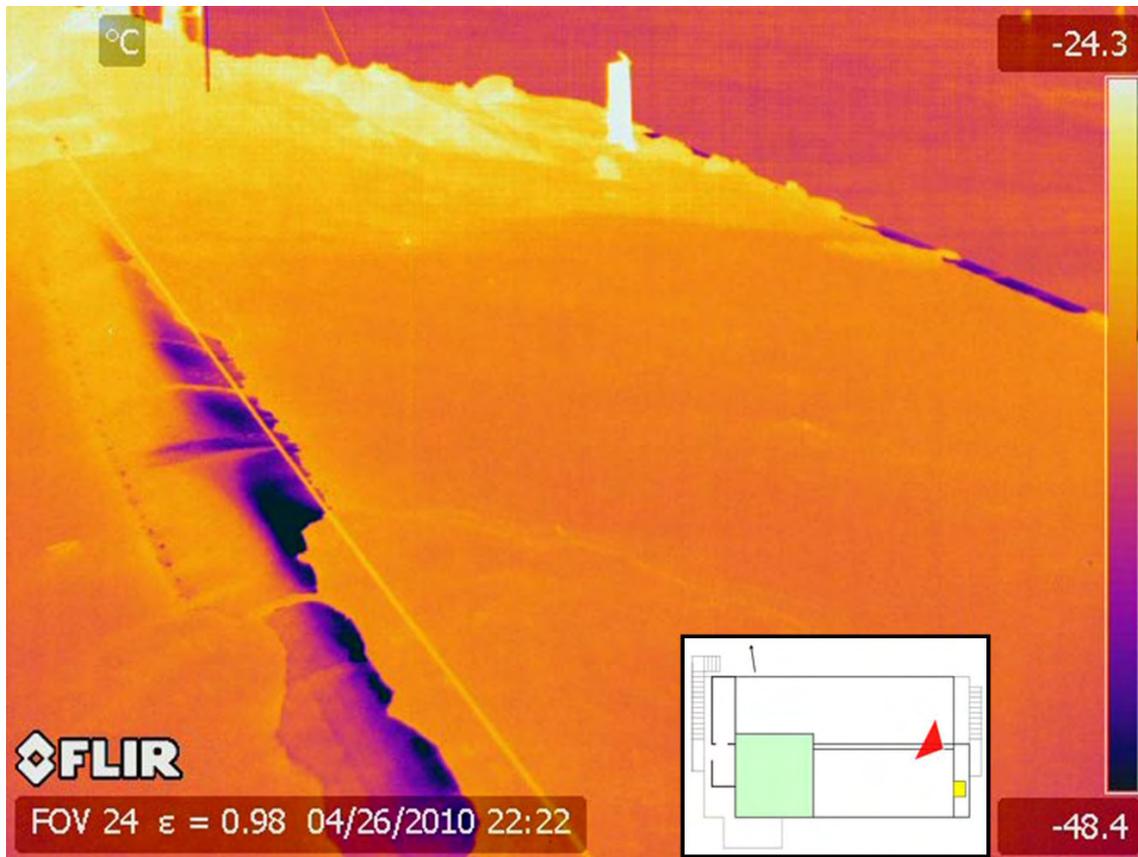
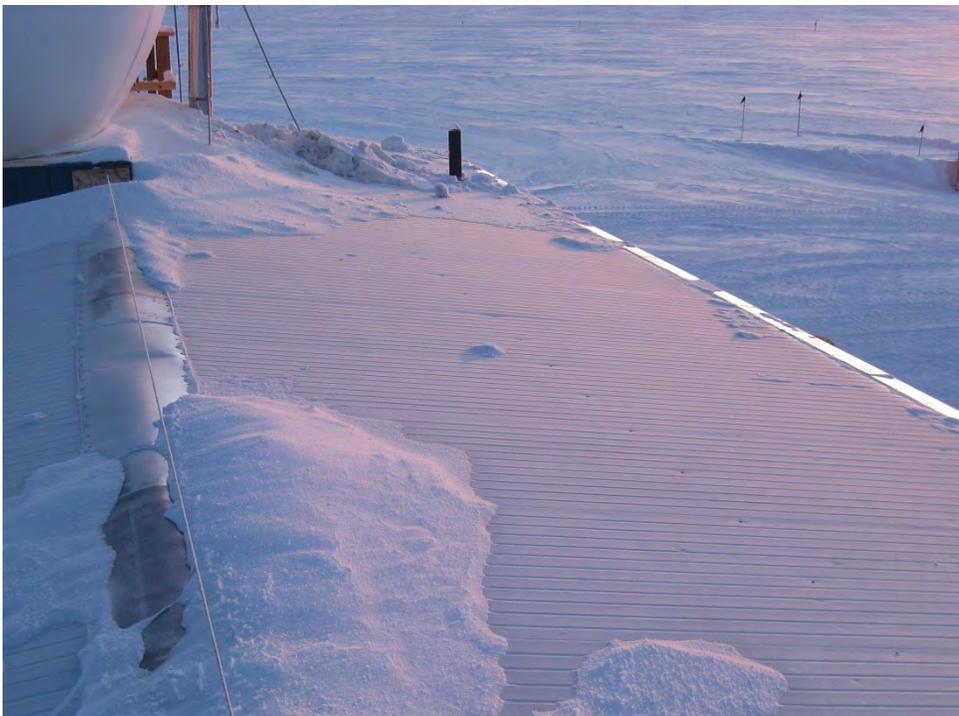
Both IR and visual images looking at the western end of the roof were taken by CPS personnel (for safety reasons) from the eastern end of the building. The images shown for **View 15** in Figures 27 and 28 are the north and south sides, respectively. The bright pipe in the northern view (Fig. 27) is the heated sewer roof vent. The view of the southern side (Fig. 28) includes the base of the radome. Aside from the previously mentioned heat loss from the support base of the radome, there is no significant heat loss from the roof. The dark areas are the reflection of the cold sky on the metal roof.

Figure 27. View 15 showing location (inset), thermal, and visual image of the northern side of the roof.

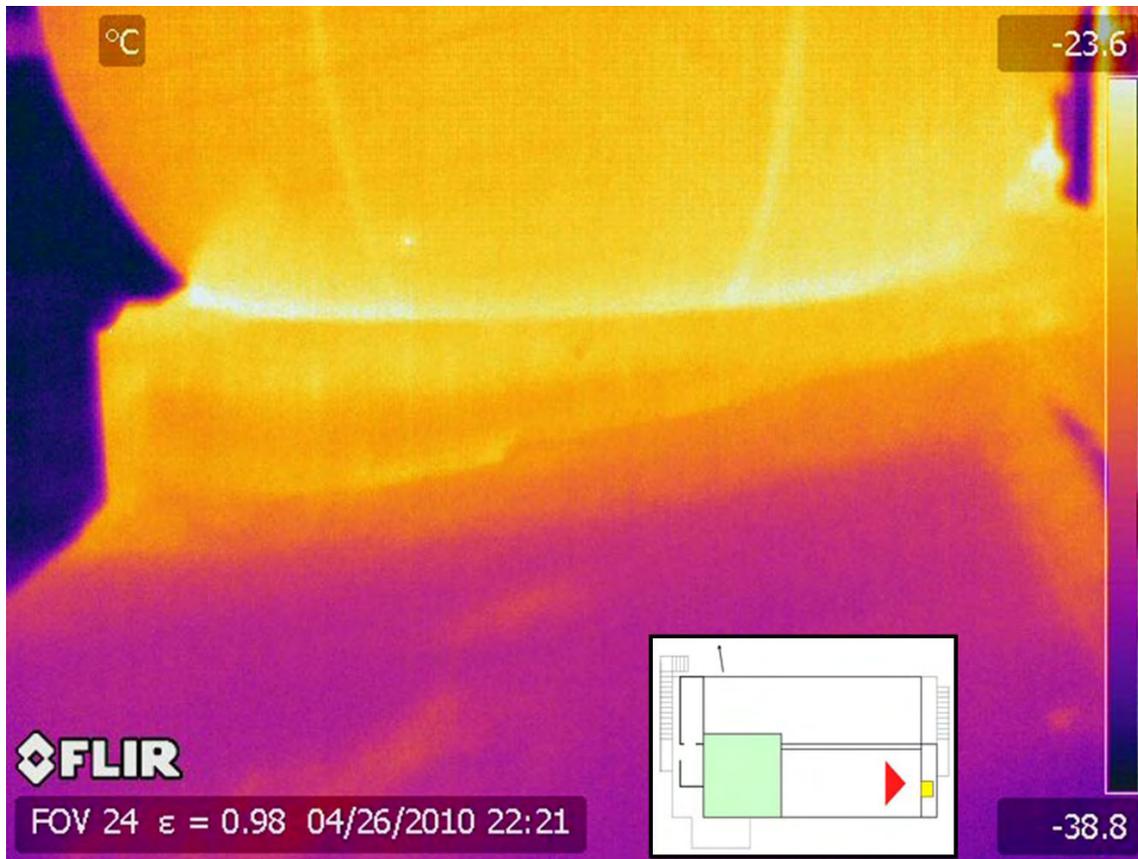
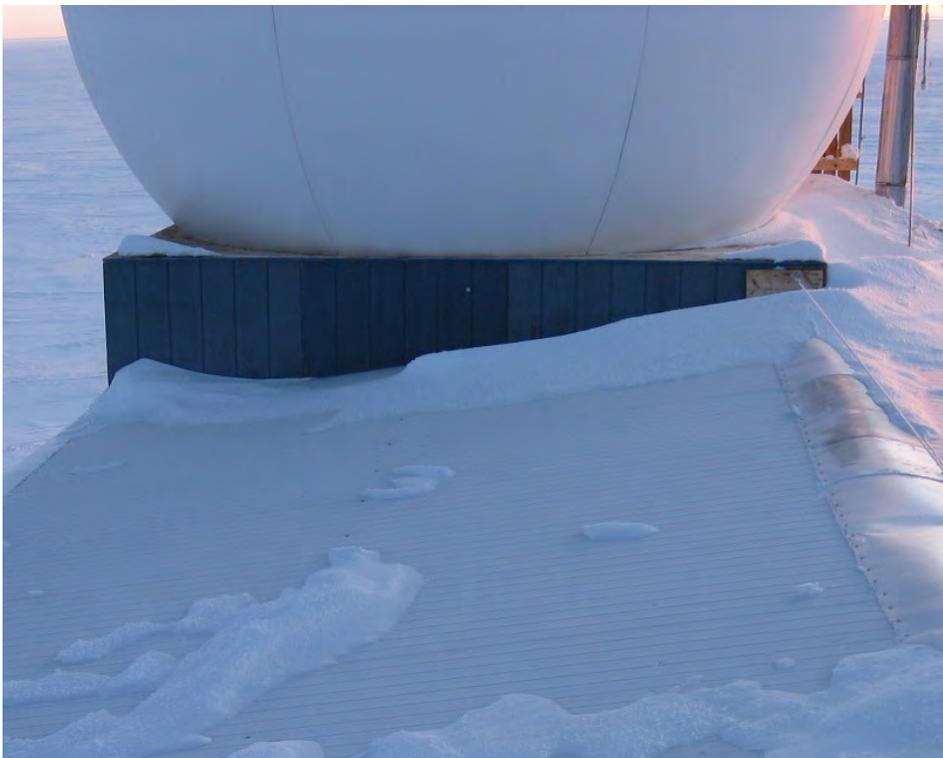
Figure 28. View of the southern side of the roof showing location (inset), thermal, and visual image taken from the same position (View 15).

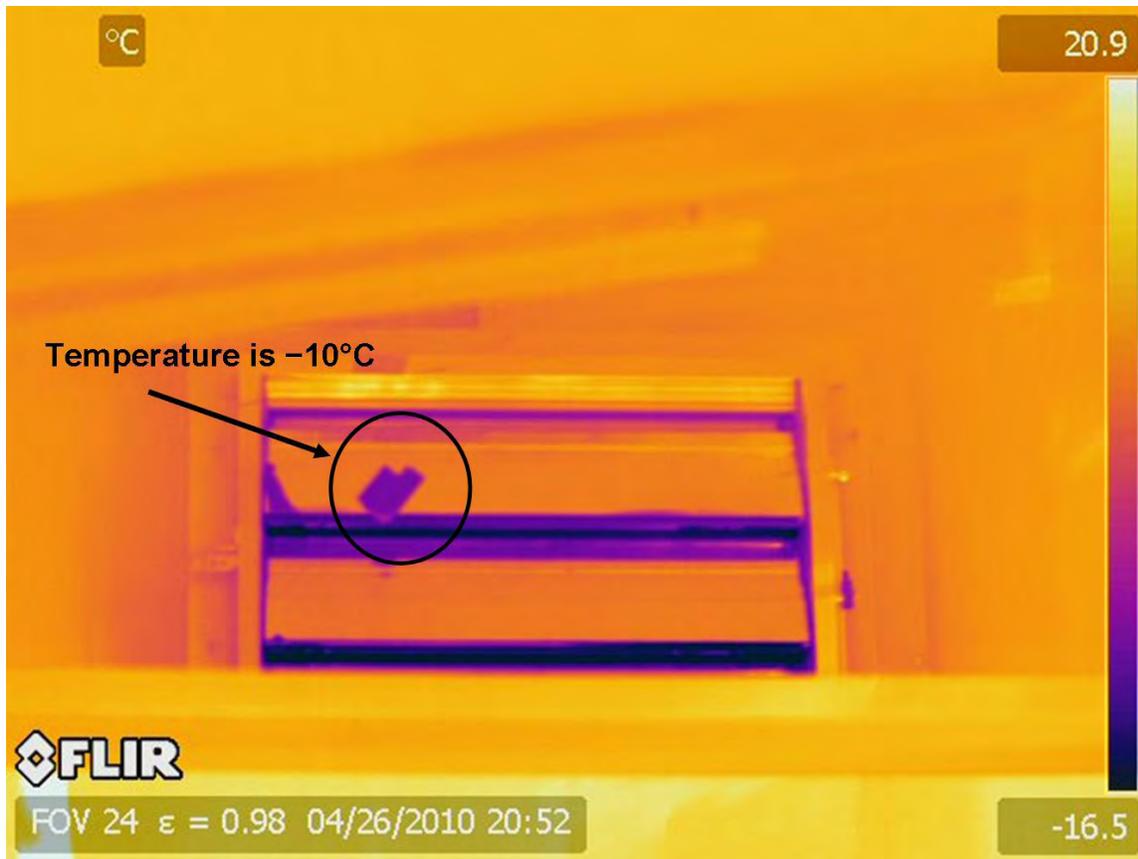
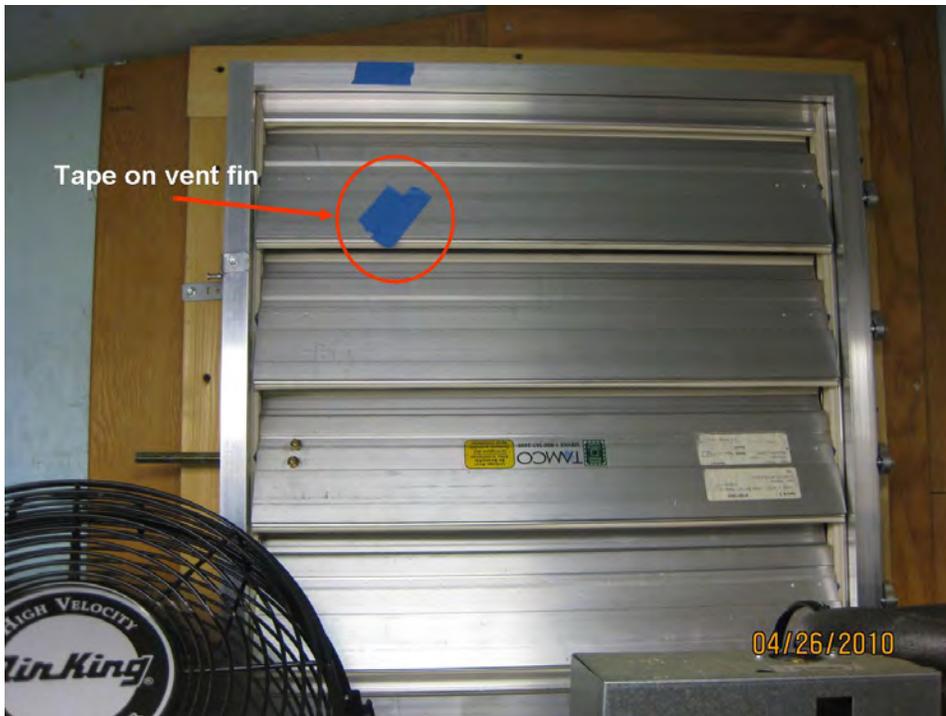
The large fresh air intake vent that brings outside air into the kitchen is a significant source of cold air infiltration (Fig. 33) and also supplies the building with make-up air for any combustion devices (such as the stove and furnace). The opening for the vent is on the underside of the building (Fig. 32). In contrast to the previous IR imagery, the dark colors here mean cold, as the vent fin is in contact with the cold air, and the warmer locations are reflected. The piece of blue tape on the top fin is reading -10°C . Also, in the west vestibule, there is frost buildup on the exterior of the vent under the shelves in the vestibule.

Figure 33. IR and visual imagery of the interior view of the large make up fresh air vent in the kitchen.

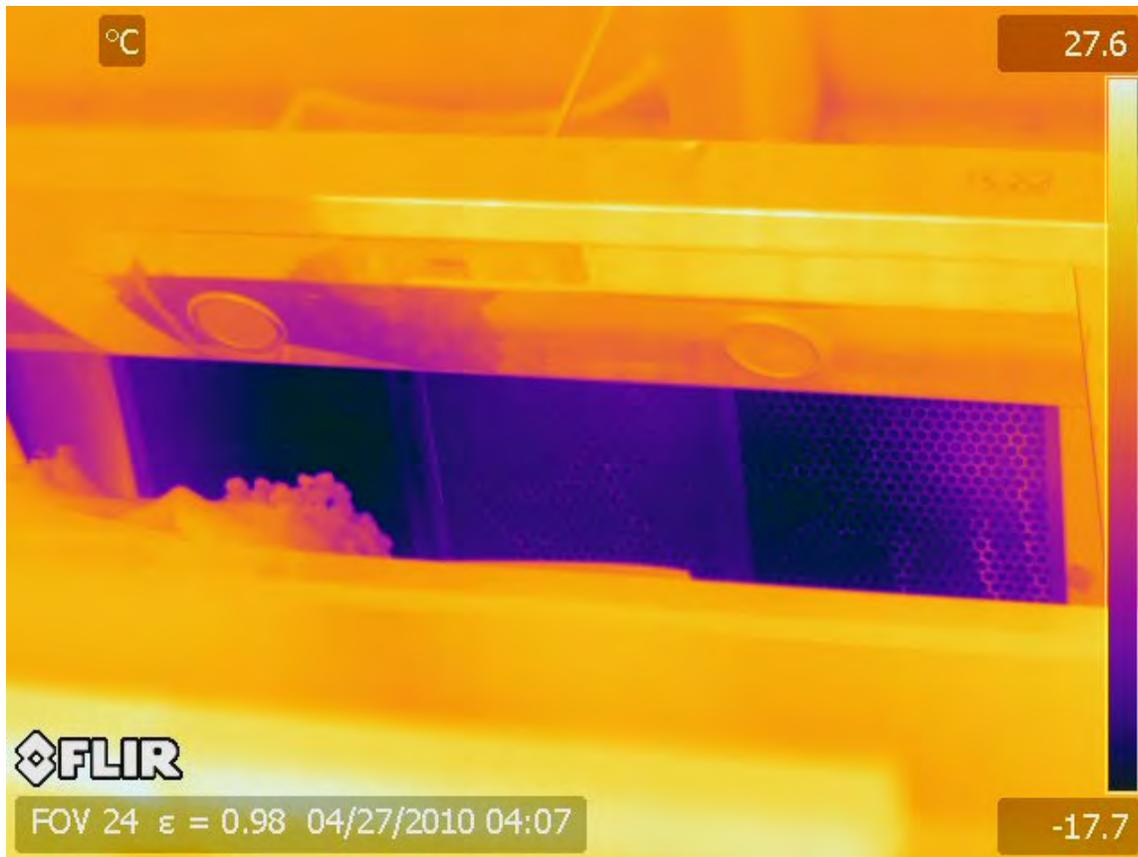
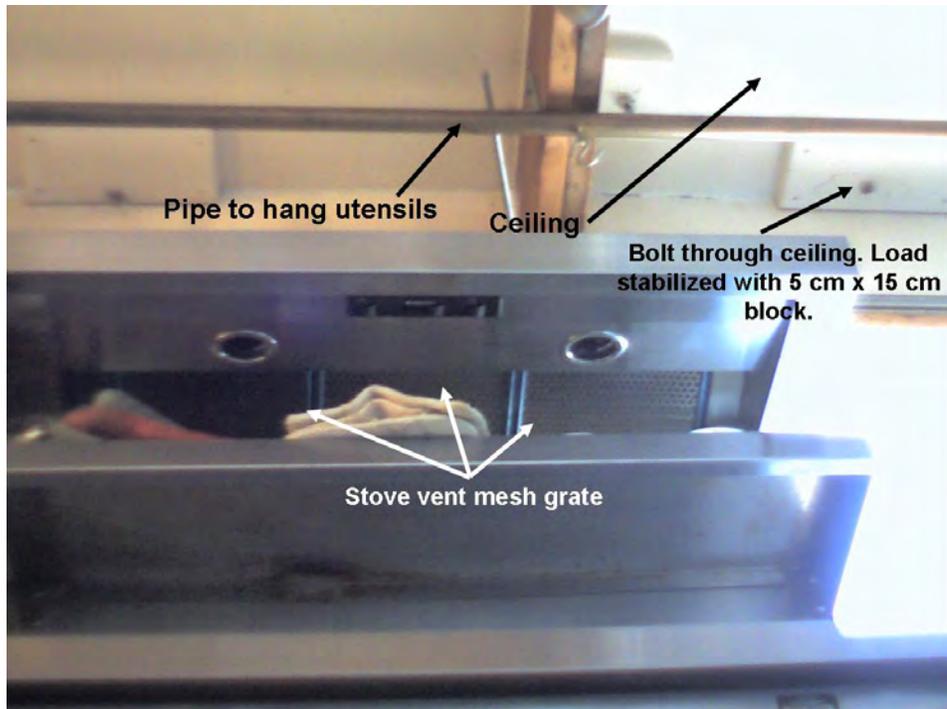
The vents located in the stove hoods are another location where cold exterior air infiltrates into the building, as shown in the IR image in Figure 34. Near this same place, on the wall behind the stove (Fig. 35), there is a cold location between two SIPs below the roof beam. This spot may be the same as the warm location seen on the exterior near the stove vents.

Figure 34. IR and visual imagery of the interior view of the stove vents in the kitchen.

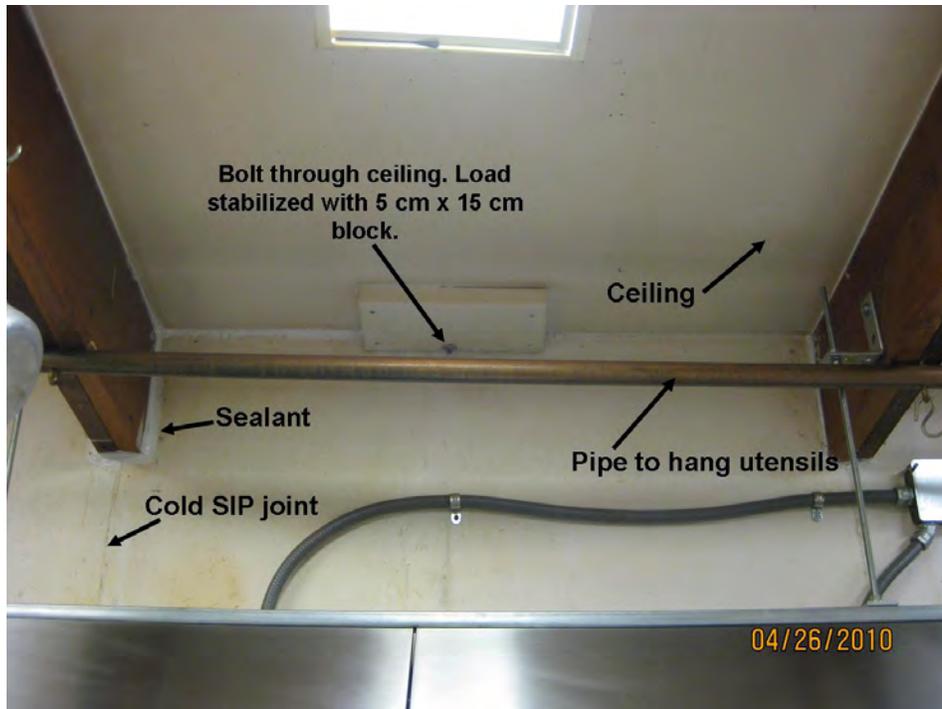
The bolts through the ceiling connecting to the base of the radome (Fig. 35) show locations of cold in the IR imagery. These are thermal bridges, and there are a number of these through the ceiling. They are condensation points for moisture in the air.

Also seen in Figure 35 is the sealant used around roof beams and along the roof-wall interface. This keeps the moisture from migrating through the wall.

Figure 35. IR and visual images of the roof-wall interface behind the stove in the kitchen.

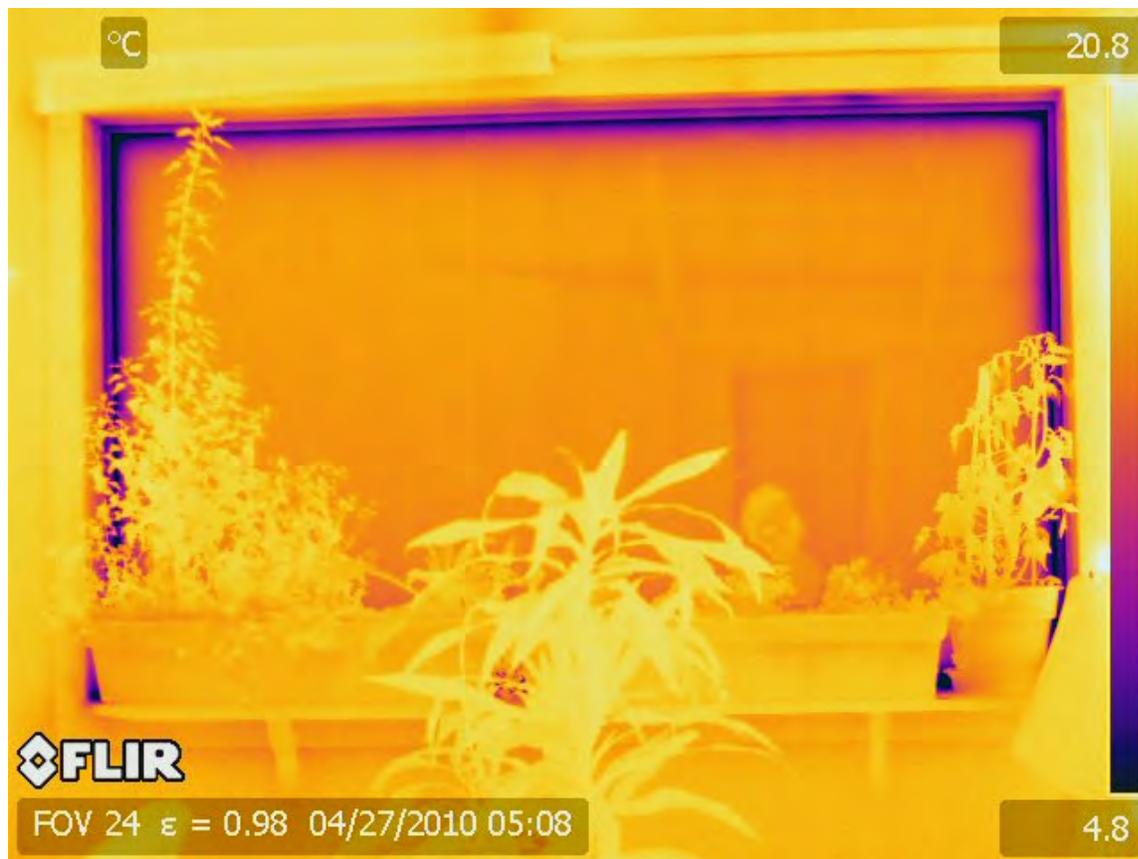
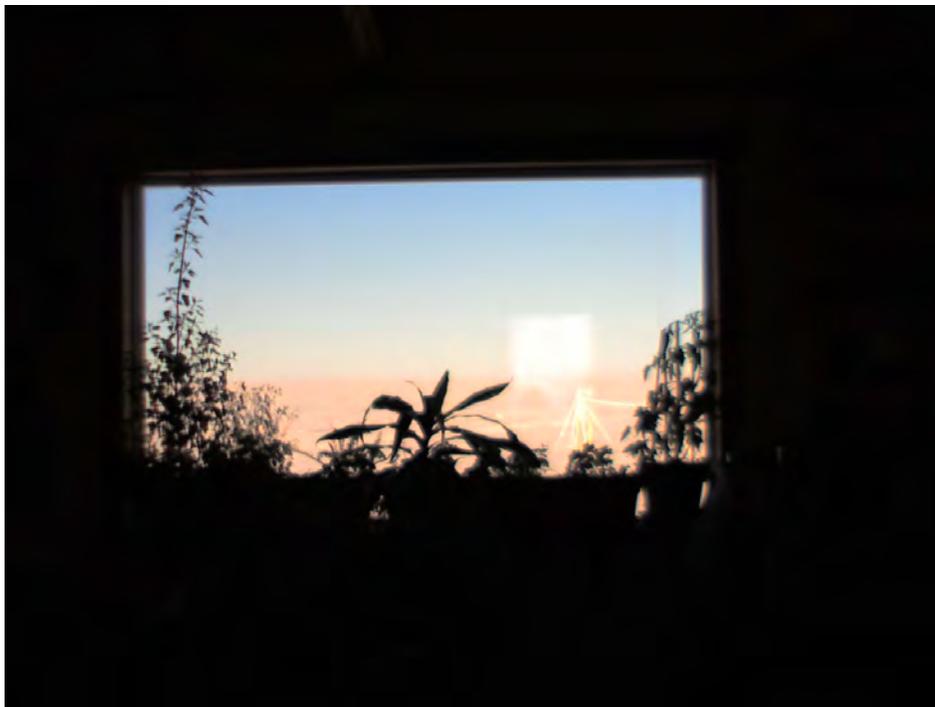
In Figure 37 the IR image of the quad-pane window shows a uniform temperature around the frame of the window. This is consistent with the exterior view and illustrates the difference in energy efficiency between the quad-pane window and the other windows.

Figure 37. IR and visual images of the quad-pane window in the main room.

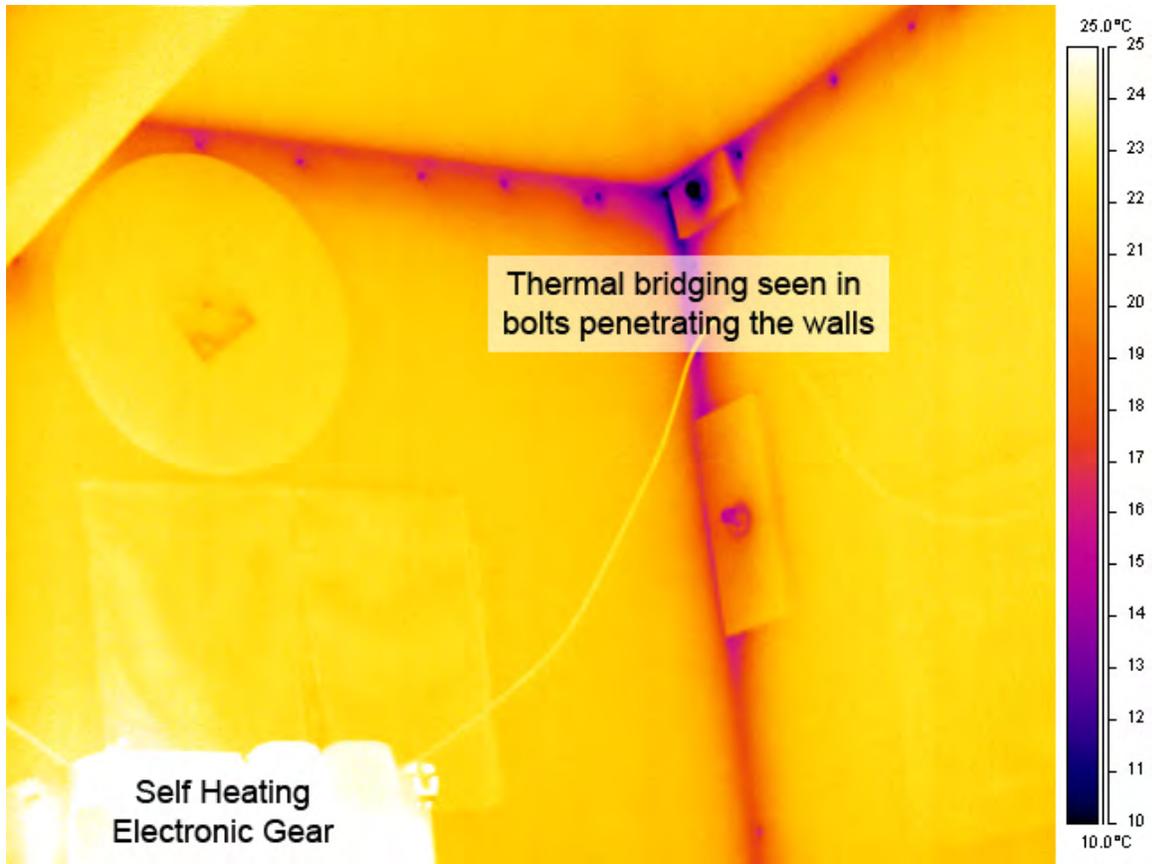
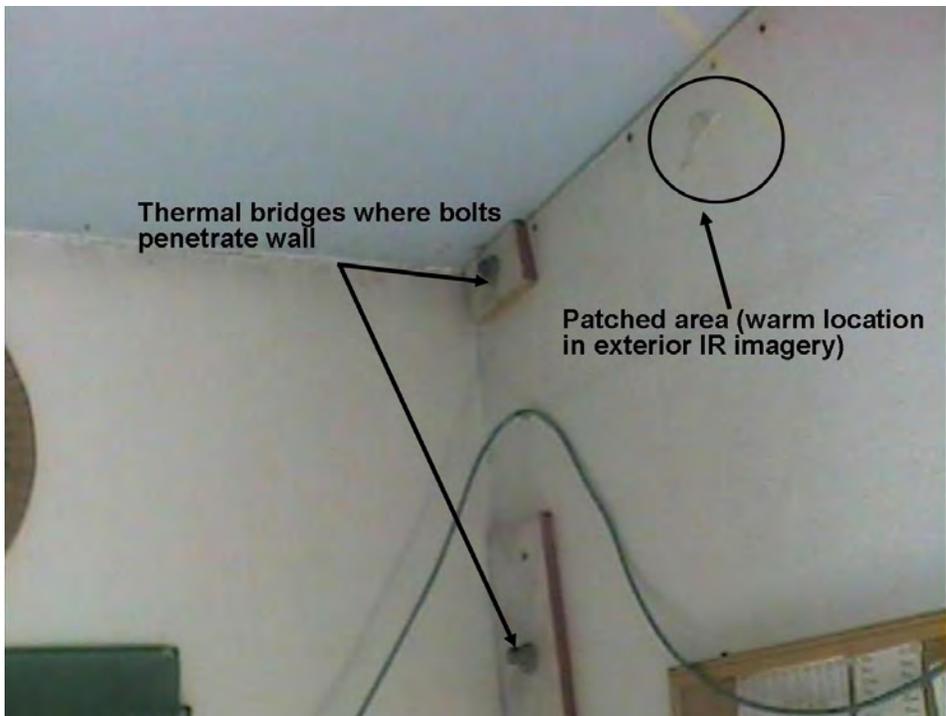
There are leaky locations that run the length of the northeastern corner in the office and also where there are bolts coming through the envelope attached to a piece of lumber on the outside (Fig. 39). Similar to the bolts through the ceiling in the kitchen, the bolts through the wall in the office are thermal bridges. Not visible on the interior is a warm spot on the wall (the location is noted on the visual image) that was visible in the exterior IR imagery.

Figure 39. IR and visual images of the northeastern corner in the office.

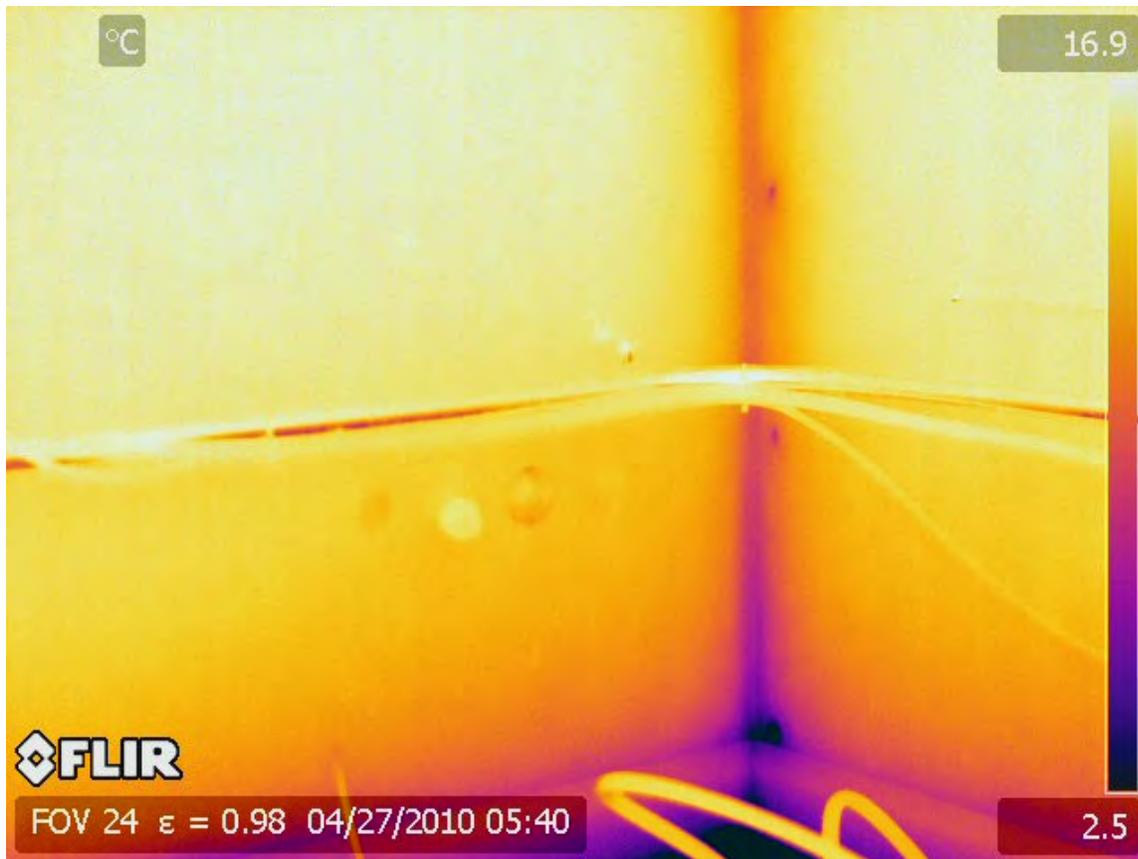
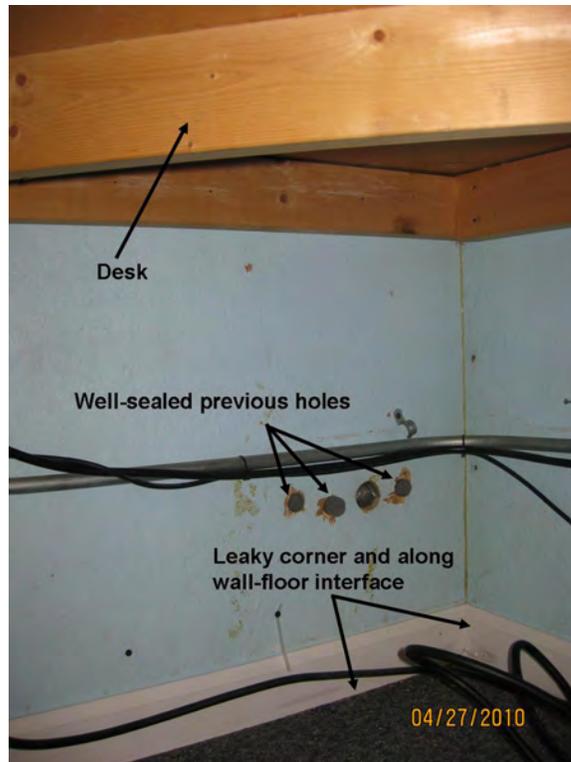
Figure 40. IR and visual images of the north-eastern corner below the desk in the office.

Below the desk (Fig. 40) are leaks at the corner and the wall–floor interface, with similar temperatures as the cold location under the counter in the main room. There are boxes and items stored under the desk that may be insulating this area so that the cold may not be noticeable to people working there. Also under the desk in this same wall were several holes that were well-sealed and did not show up in the IR imagery. It is recommended that previous penetrations to the building envelope that are no longer needed to support instrumentation be removed and completely re-insulated and sealed.

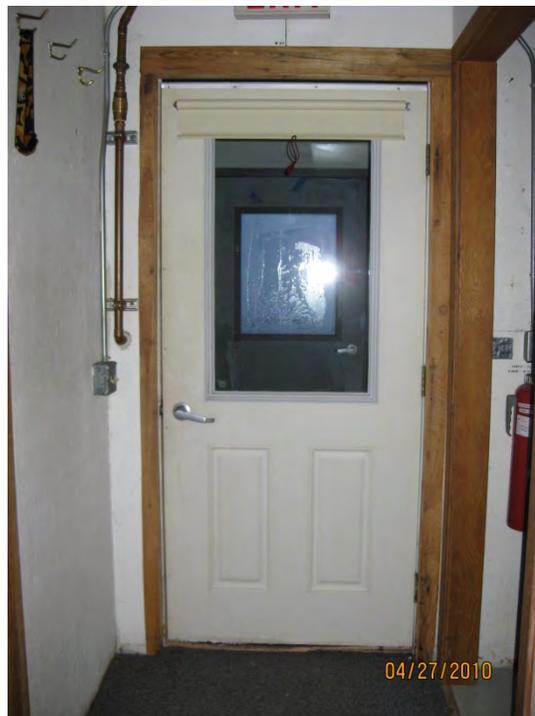
Figure 43. IR and visual images of the main entrance door in the west vestibule.

image in Figure 43 for the entry on the western side shows significant air leakage at the threshold under the door and along the sides. The framing in the wall is visible in the IR image, suggesting that additional insulation or sealing may be needed. This entryway receives heavy traffic as it is used to carry heavy boxes and items to the kitchen for food preparation.

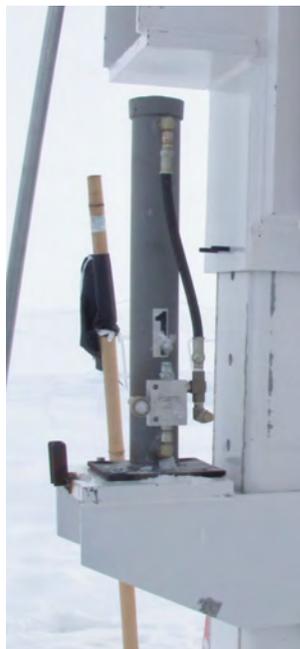
The lifting procedure requires lengthening, when necessary, the steel columns to provide vertical height. The height of the column is typically sufficient for two lifts, and as a result extensions are added every other lift. Hydraulically operated jacks are placed between the center traveler of the column and the lower jack stand (Fig. 44) (CPS draft).

Figure 44. Position of hydraulically operated jack for lift procedure (CPS draft).

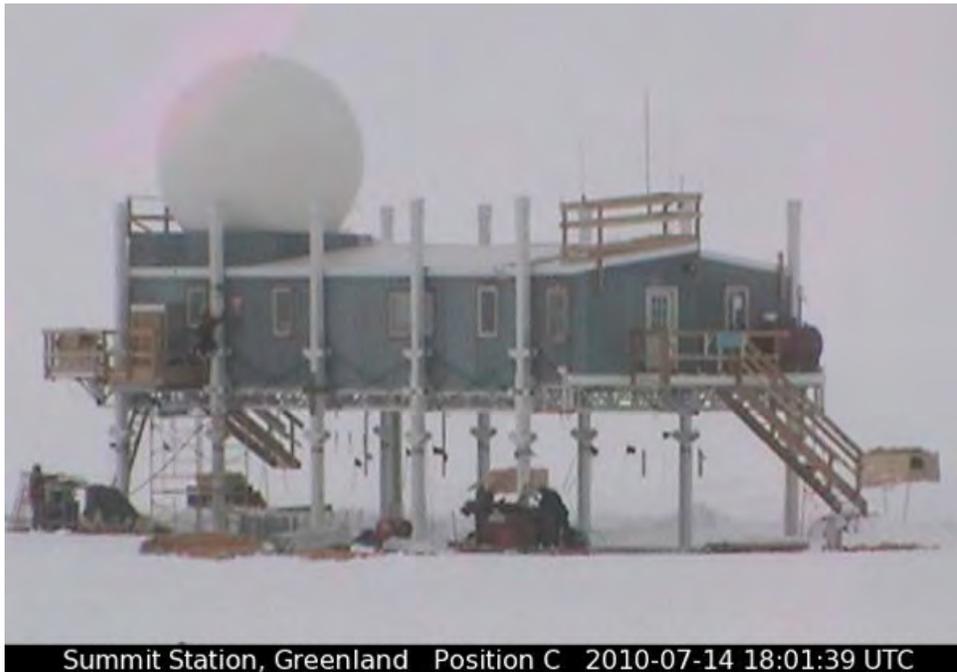
For previous lifts, each column was lifted separately. A new hydraulic pump system was designed and used during the 2010 summer season that allowed the entire structure to be lifted, decreasing the amount of time needed to lift the building. Figure 45 shows the Big House after it was lifted during the summer 2010 season.

Figure 45. Completed lift of the Big House during the 2010 summer season.
